# FINAL INVESTIGATION REPORT

**M/V “AL SALAM BOCCACCIO 98”**

**February 03<sup>th</sup>, 2006**

***R-054-09/DIAM***

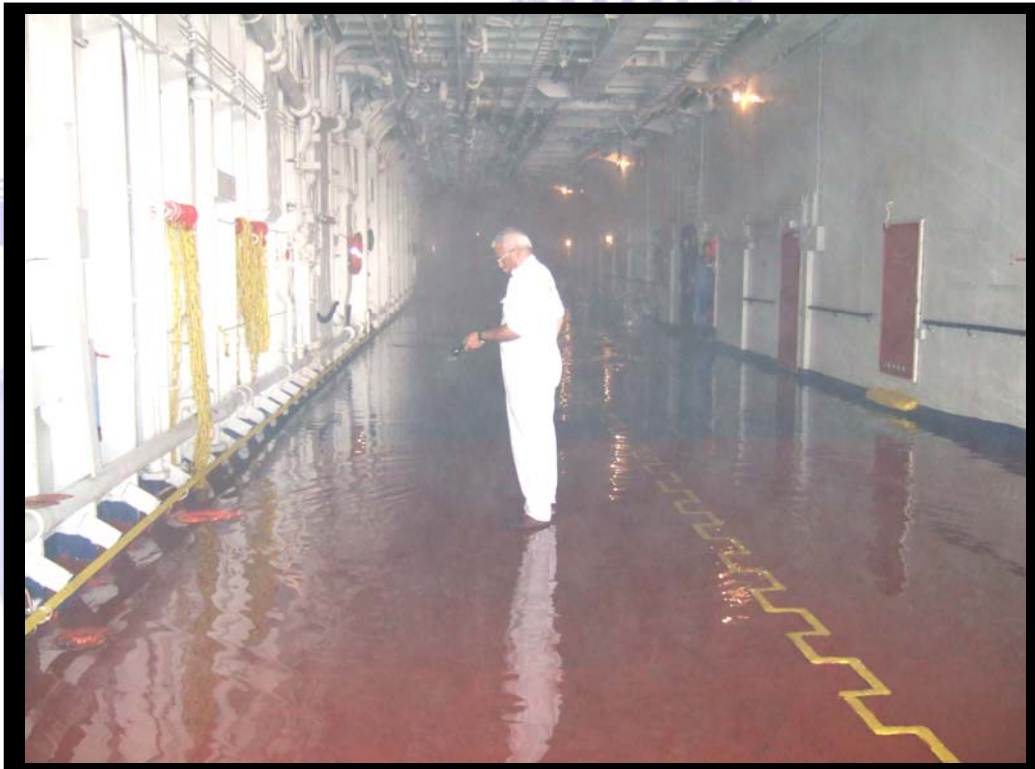
**Figure 5**

*Scuppers testing with the sprinklers*

Note: According to the evaluation carried out on board one sister ship, in ideal conditions, it was clear that in a short period of time (i.e. 10 minutes), the accumulated amount of water can rapidly increase in the car deck.

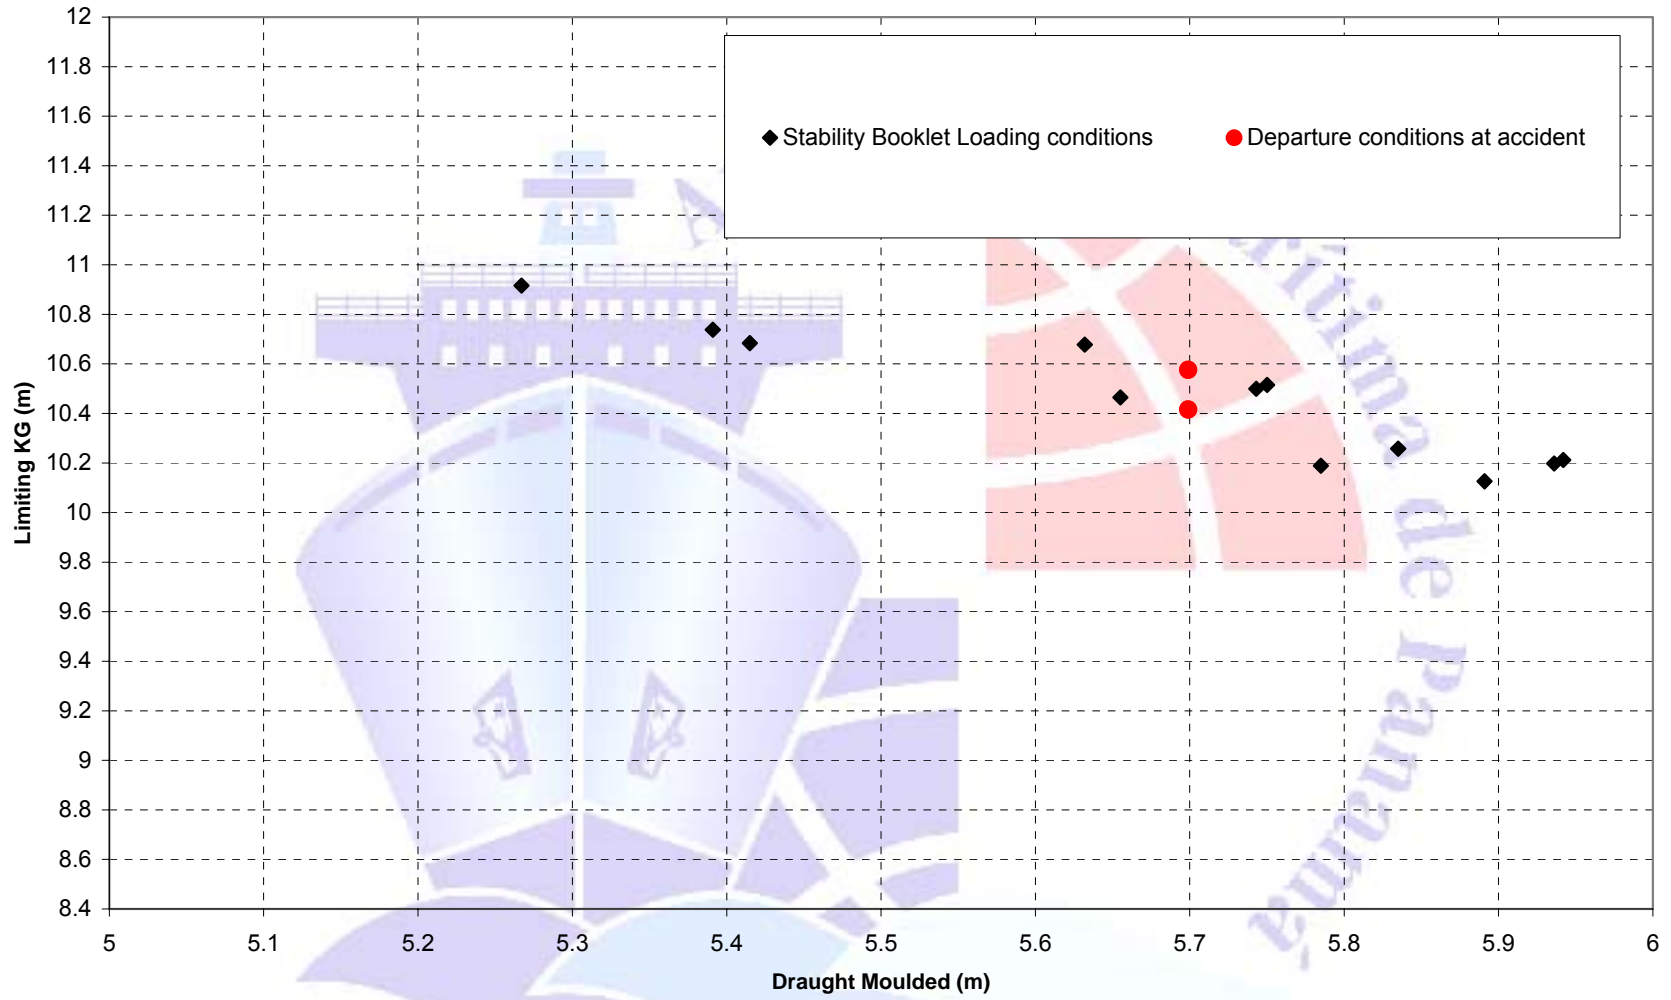
Figure 1 – Departure conditions at accident and stability booklet loading conditions

The two departure conditions at the time of the accident can be seen along with the existing stability booklet loading conditions in Figure 1.

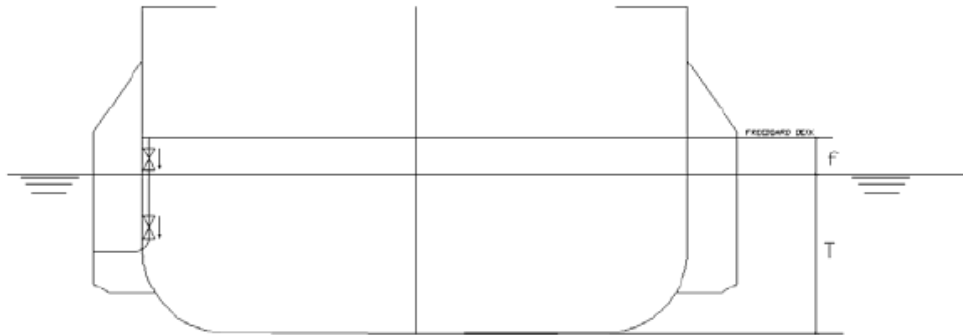
Diagram of scupper layout

Tests excluded the fire hose flow factor from the reconstruction, but in a separate sensitivity test based on the assumption that all three of the fire pumps on the vessel were in operation during the fire, it would take a determinate amount of scuppers to evacuate the flow safe and expeditiously. Testing was done on an 18,000-second flooding simulation, with progressive opening of scuppers to determine how many were in operation before the capsizing. Tests were ran using conditions of 1, 2 or all 3 pumps in operation. The results of the number of scuppers and time frame for capsizing were a bit irrelevant since it was inconsistent with VDR data. A result showed that if all 3 fire pumps had been in operation for the entire duration then the equivalent of between 11 and 13 scuppers would have had to be in operation for the capsizing time to match the VDR data.

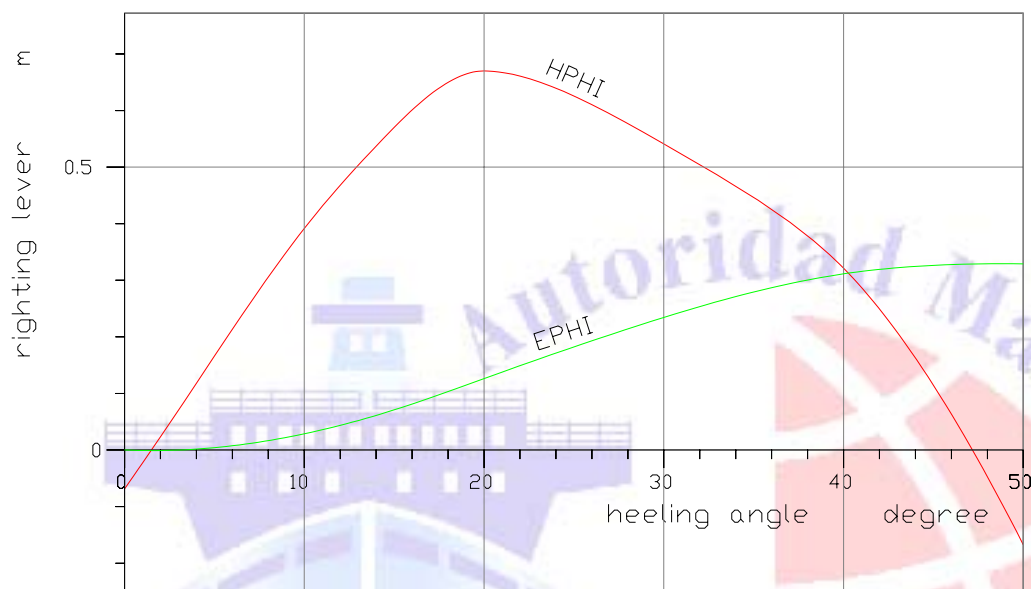
*GZ of ship with no water on the deck. HPHI is the GZ curve, EPHI is the area under the GZ curve*

**Figure 6** shows the GZ curves for the ship just before capsizing. This shows that at this point, due to the accumulation of water on the garage deck the vessel has very little positive stability and is also in a condition known as Loll.

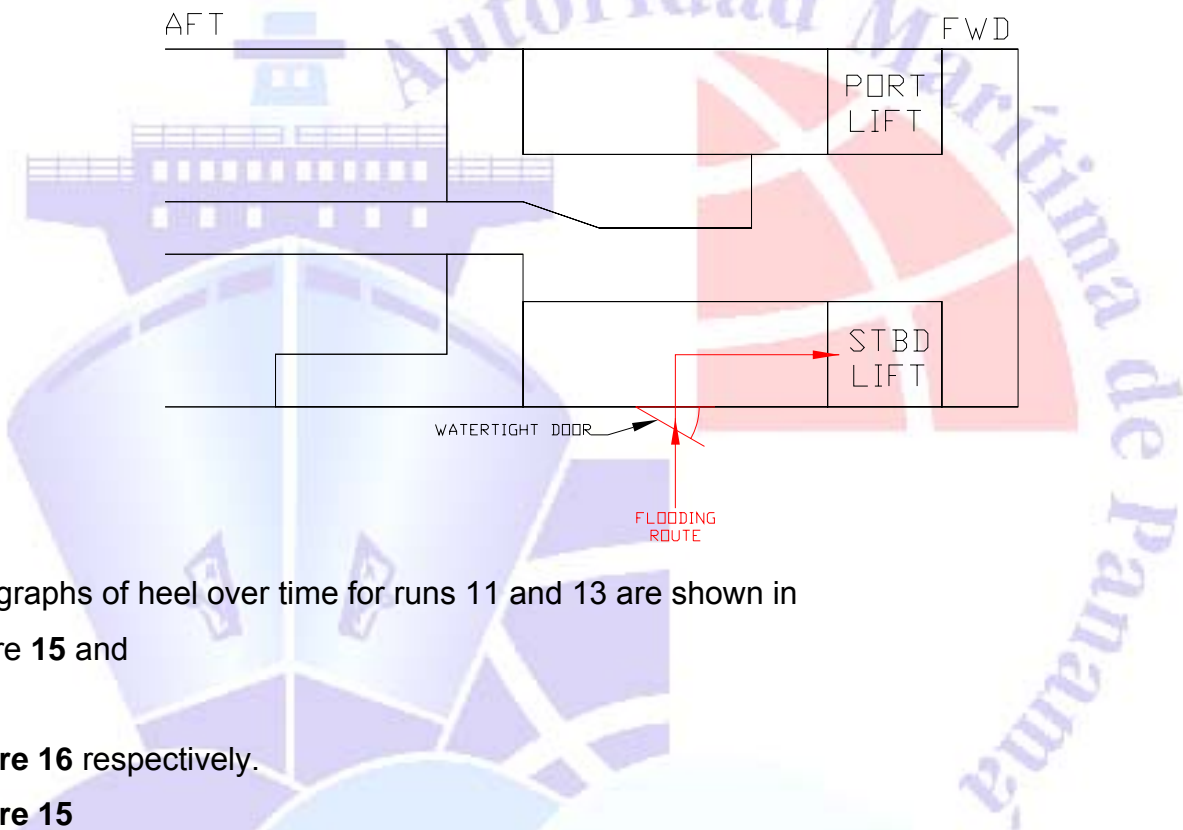
**Diagram showing the flooding route on the garage deck through the centre casing down through the starboard lift to the forward crew accommodation.**

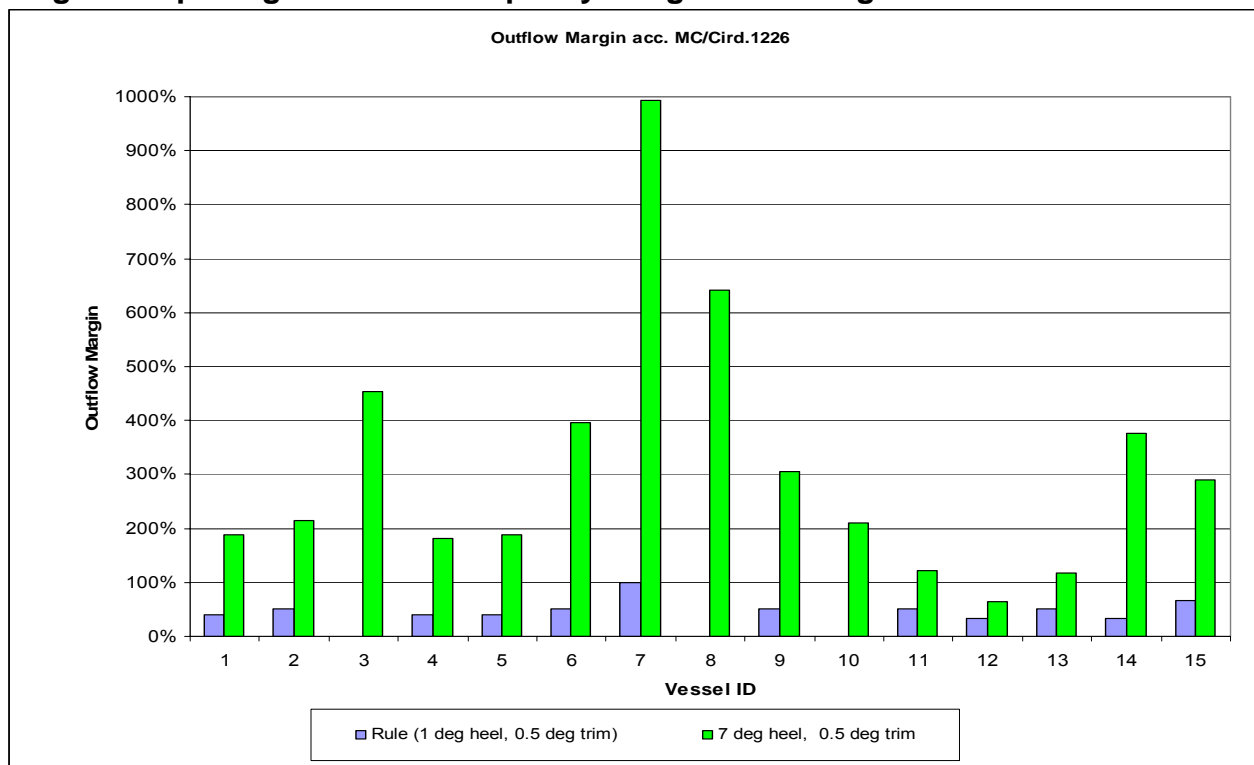
**Figure 32**  
**Diagram depicting the outflow capacity margin according to MSC .1/Circ. 1226**

Ps 3, 8 and 10 have 0 % outflow margin for 1.0 ° heel which implies that the scupper outflow capacity matches the scupper flow onto the car-deck. This is due to the very small amount of water required to heel these vessels (as it can be seen in **Table 11**, The scupper spacing is 9.0 m so there are only a few scuppers covering the area of localized water wedge. Therefore there is no outflow margin for small heel, however a margin can be observed for the same vessels at 7° heel.
