**Technical Report**  
**Issued by the technical Committee**  
**established to Investigate and analyze the causes**  
**which led to the sinking of the Passenger Ferry**  
**Al Slam Boccaccio 98 in the Red Sea in**  
**February 2006**

Arab Republic of Egypt  
Alexandria  
June 2006

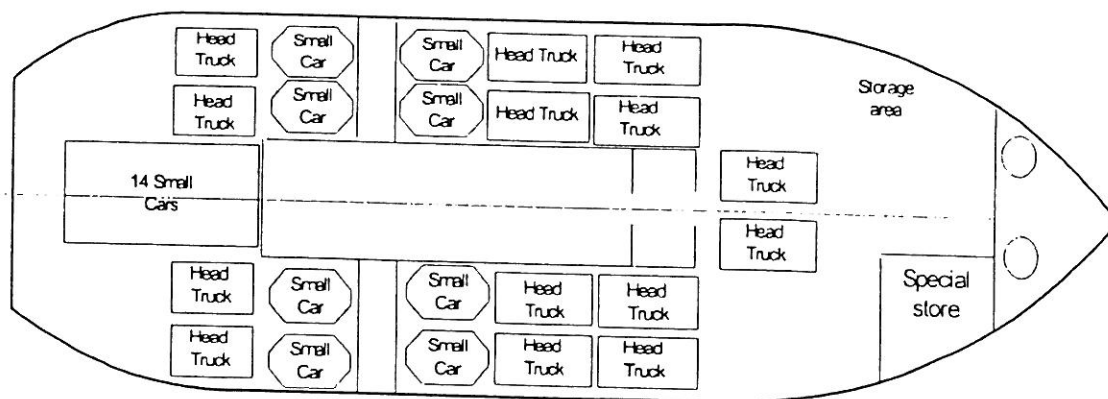
The figure shows the cargo plan according to crew statements

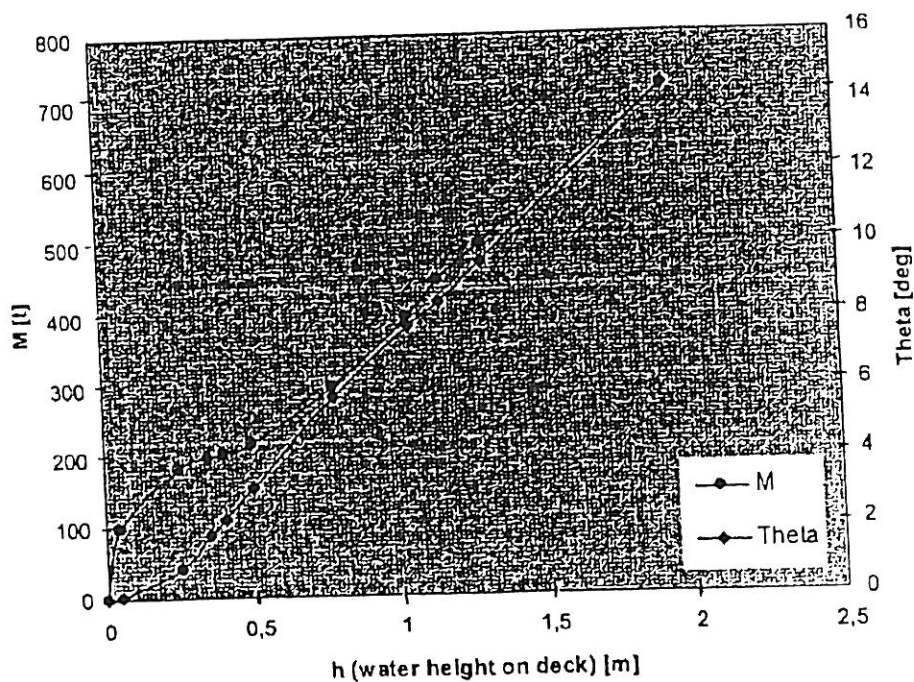
Figure 2

M (Mass of water on deck) - Theta (heel angle)

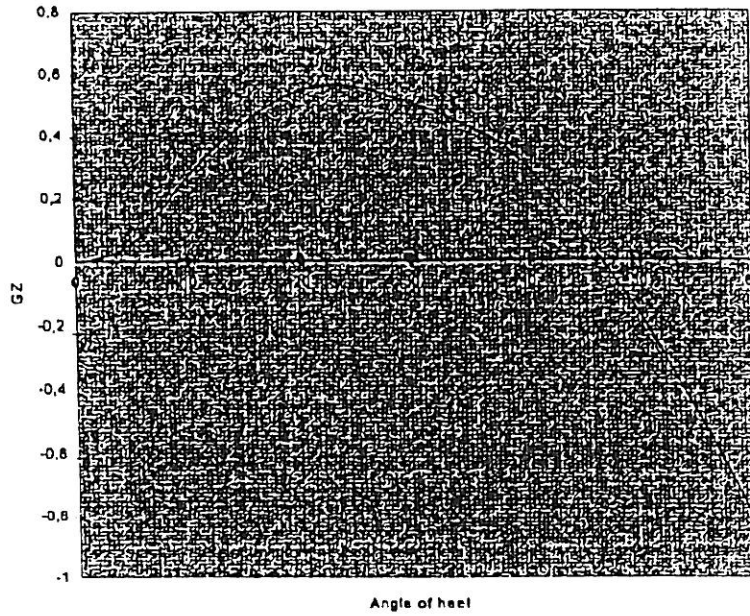
Figure 3 (M=185 t)

Stability diagram

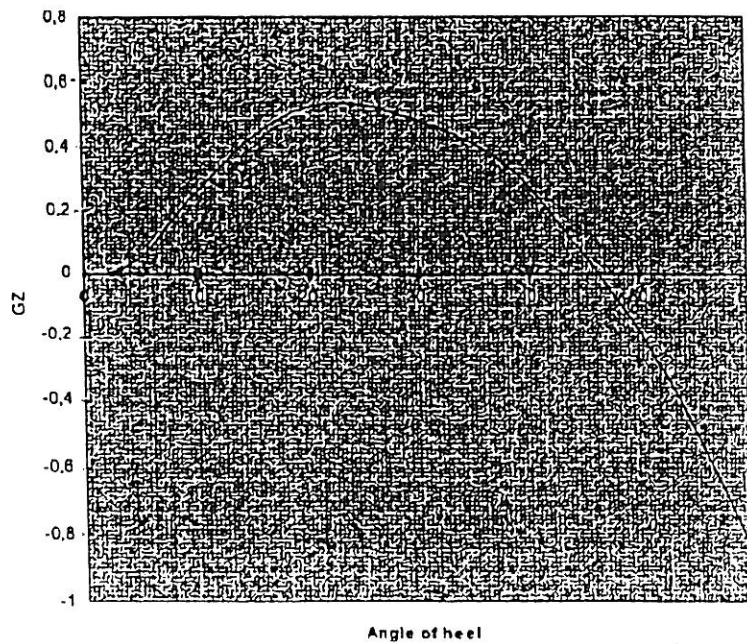
Figure 4 (M=205 t)

Stability diagram

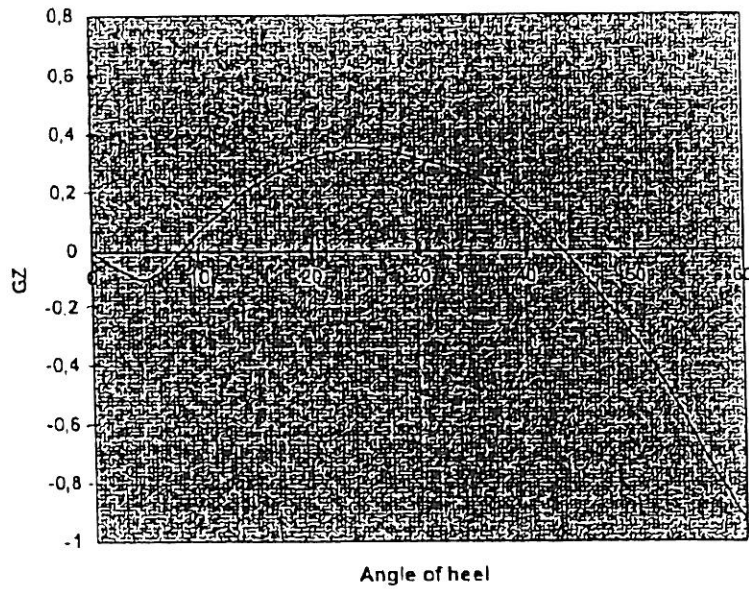
Figure 5 (M=450 t)

Stability diagram

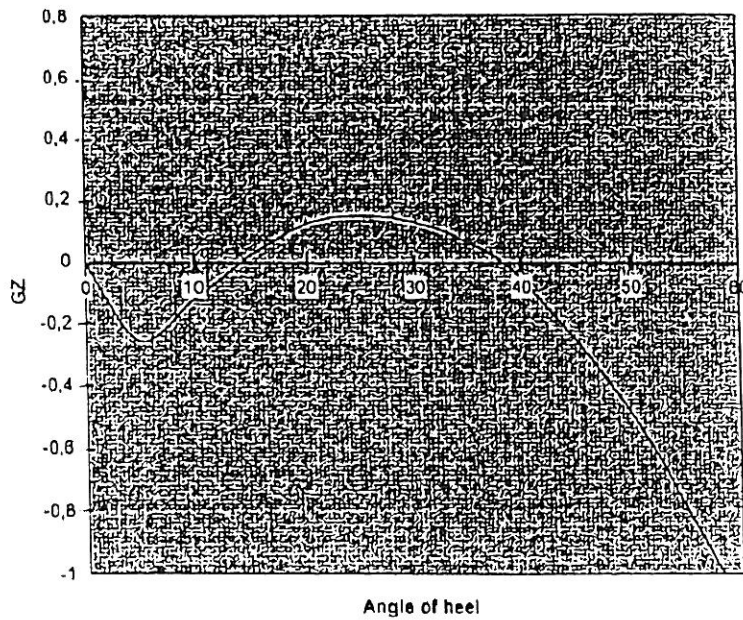
Figure 6 (M=720 t)

Stability diagram
