# FINAL INVESTIGATION REPORT

**M/V “AL SALAM BOCCACCIO 98”**

**February 03<sup>th</sup>, 2006**

***R-054-09/DIAM***

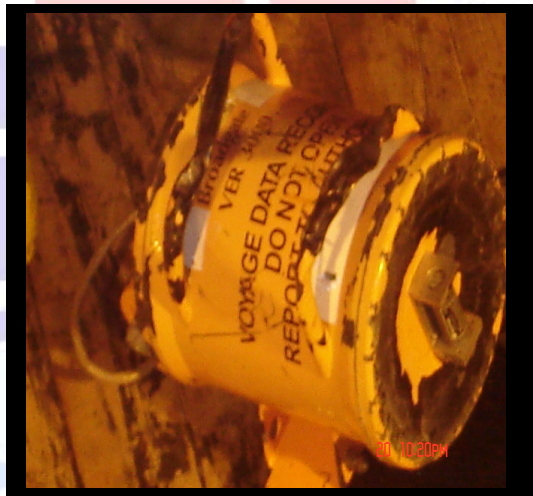
Figure 10

At the time of the recovery of the VDR, the wreck was found at a depth of 912 meters lying on her starboard side. The ROV carried out a survey where the ramp of the vessel was observed to be still closed.

*The recovered VDR of the AL SALAM BOCCACIO 98*

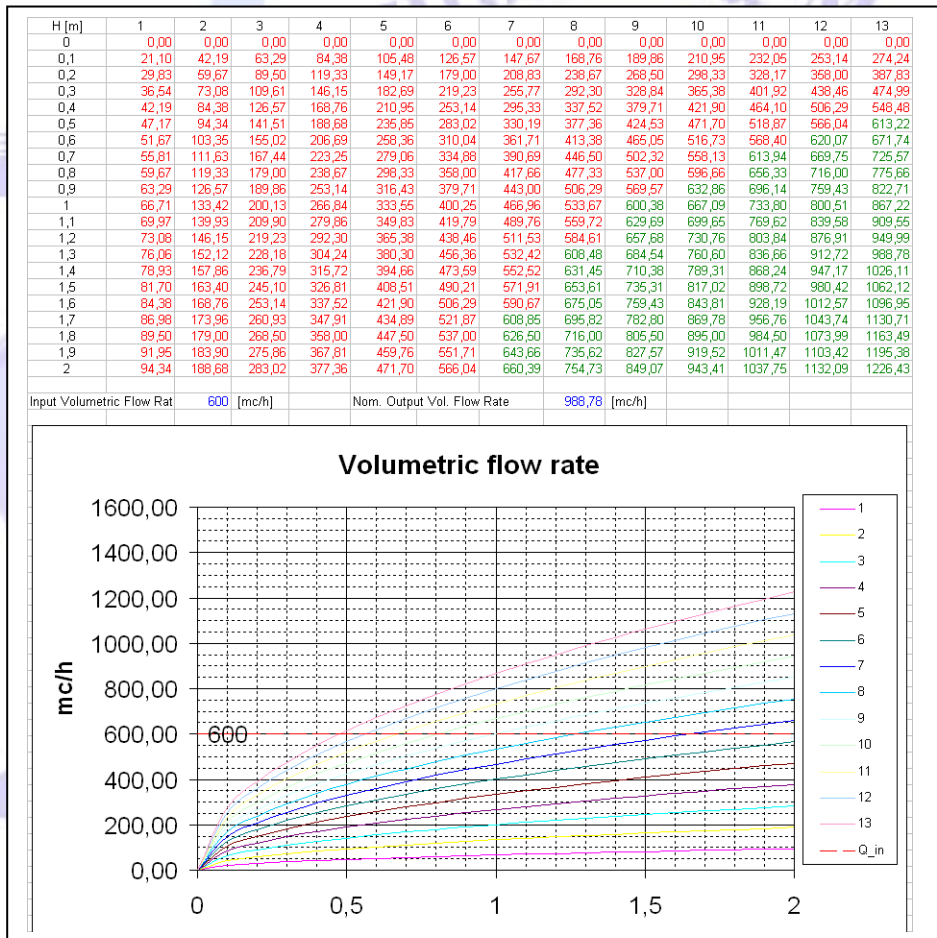
The results are summarized in the following Table, where the output flow rate is calculated for a finite set of total hydrostatic head values (in columns) and number of scuppers (in rows). A value of input flow rate of 600 [m<sup>3</sup>/h] is assumed. The combinations H / number of scuppers that are sufficient to discharge the input flow rate are printed in green while those that are not sufficient are printed in red. The same results are shown in a graphical form with the volumetric flow rate as a function of the total hydrostatic head and the number of active scuppers as a parameter.

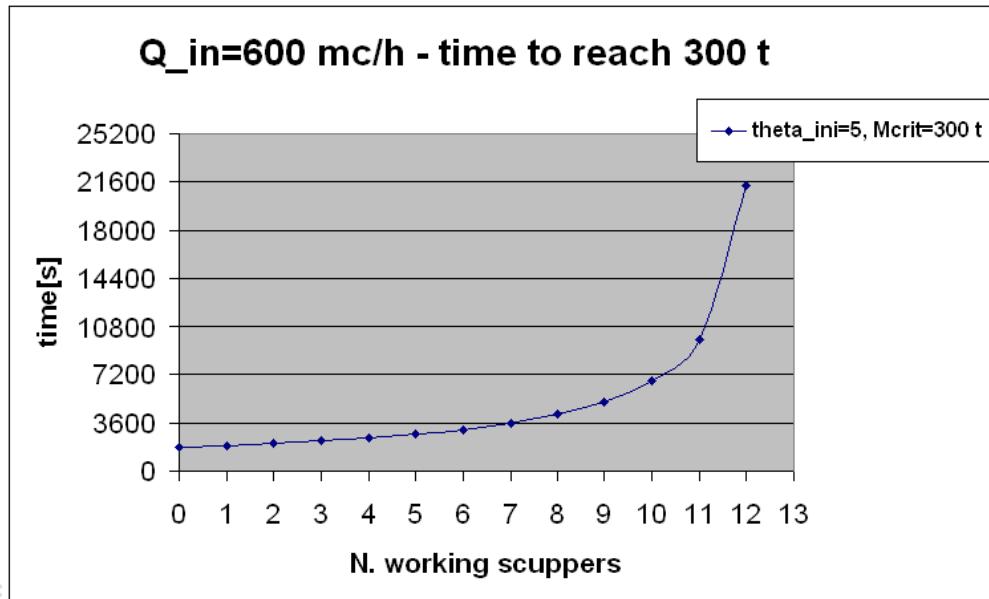
**Figure B 3**

The results obtained with a constant input flow rate of 600 [m<sup>3</sup>/h] and an initial angle of heel of almost 5 degrees are shown in Figure B3 below.

The resulting time for 13 active scuppers has not been graphed because it can be considered as infinite.

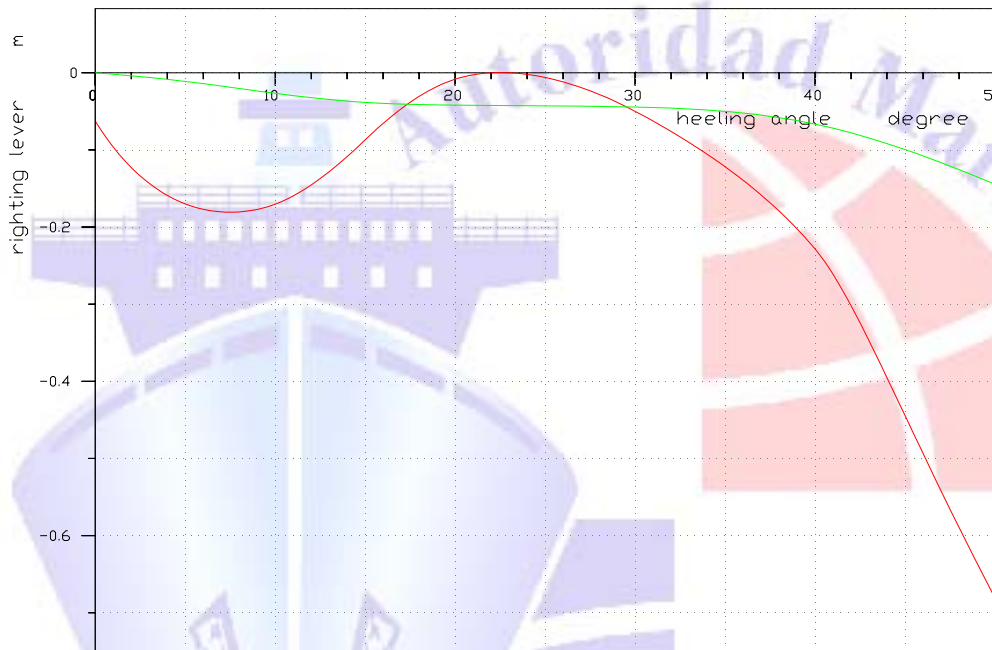
**Figure 6** shows the GZ curves for the ship just before capsizing. This shows that at this point, due to the accumulation of water on the garage deck the vessel has very little positive stability and is also in a condition known as Loll.

**GZ curve of Al Salam Boccaccio 98 with approx 930 tonnes of water on the deck. HPHI is the GZ curve, EPHI is the area under the GZ curve**

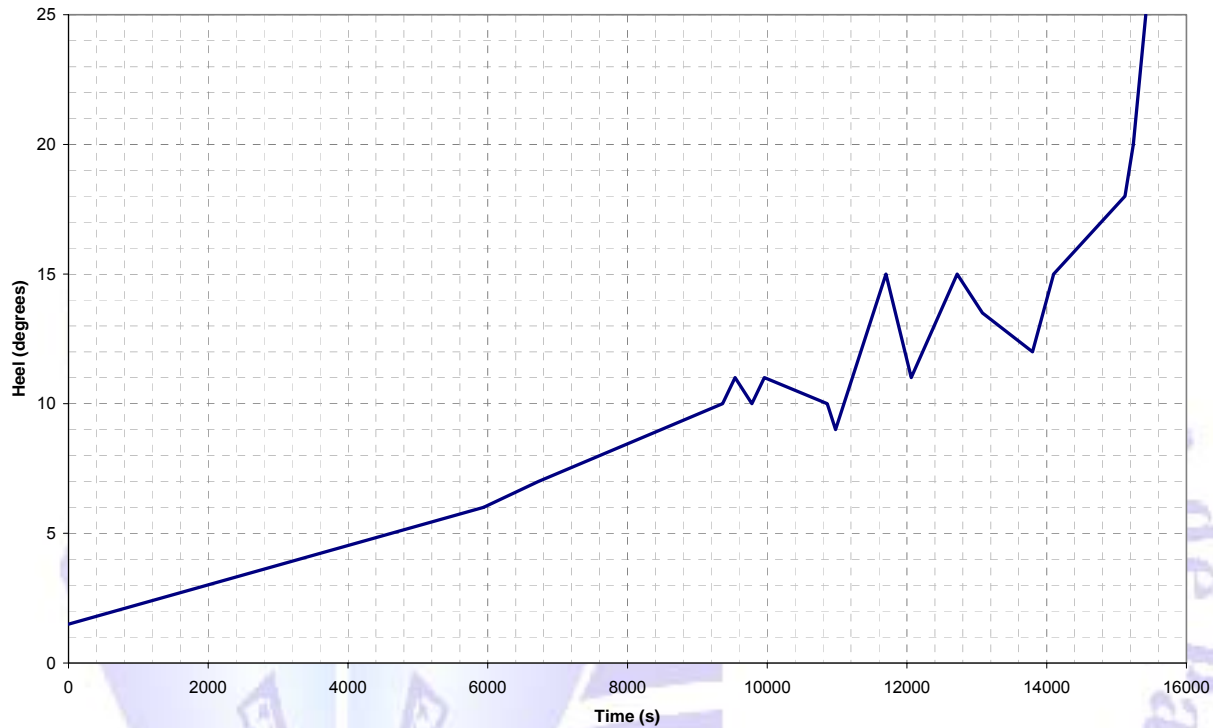
**Figure 8**  
**Graph of heel over time from VDR data**

***The following graph shows the heel progression over time from the VDR data.***

The aim of the dynamic analysis was to try and establish a possible scenario which matched as much of the VDR data as possible and also the capsized in the same time as shown in the VDR data.

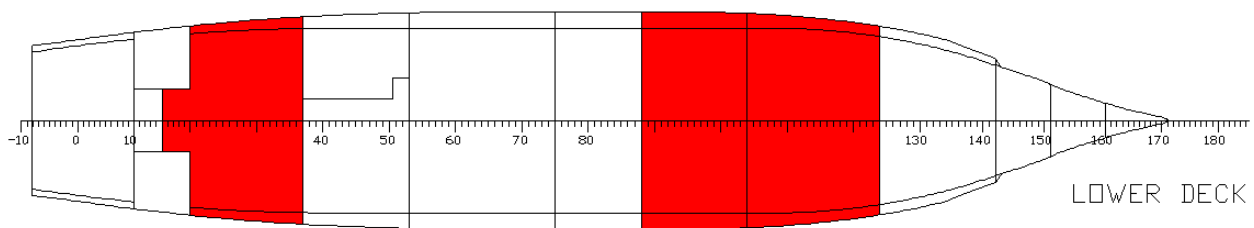
**Figure 9**

Below the car deck there are three areas of crew accommodation, two areas forward and one area aft. This is shown in Figure 9. The two forward accommodation spaces are joined by a watertight door. The crew member however, did not state which crew accommodation it was that flooded. By analyzing the available drawings we were able to identify possible flooding routes for all the crew accommodation areas.

***Drawing showing the forward and aft crew accommodation spaces highlighted in red***

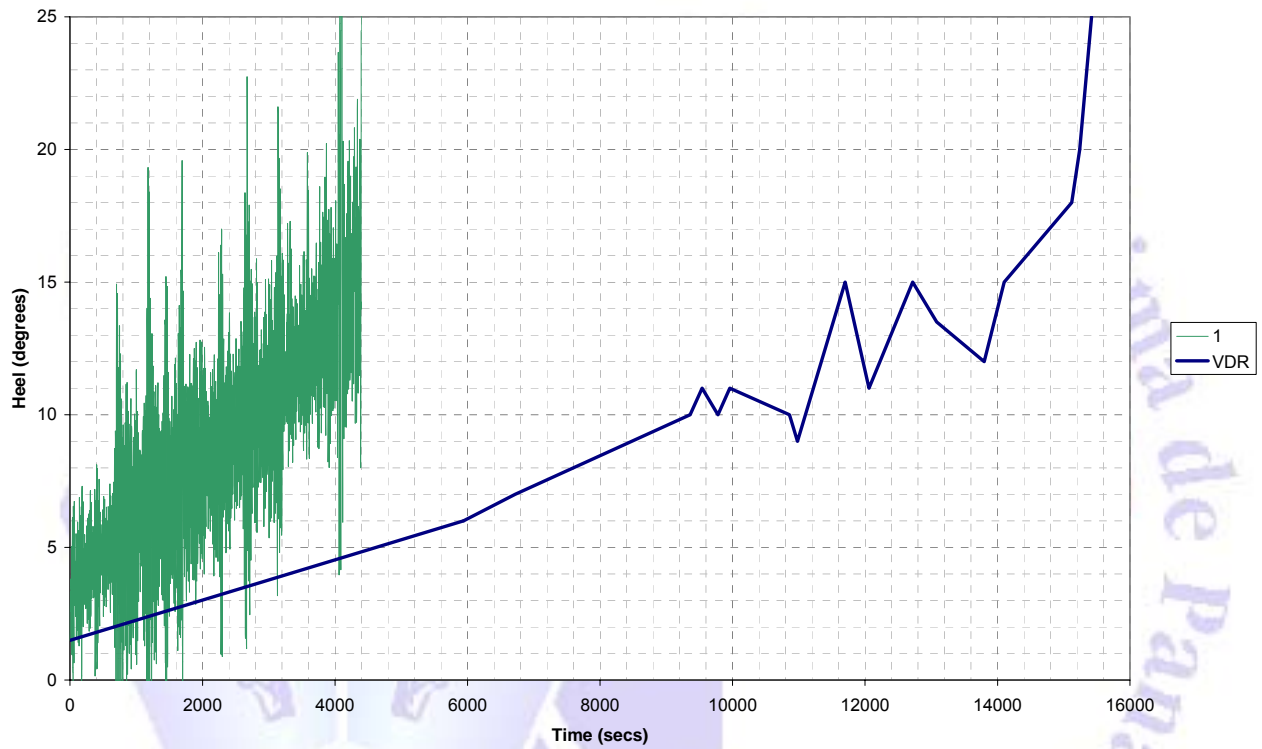
**Figure 10**

**Heel over time for Run 1. Scuppers not operating, 3m/5.5sec zero crossing period wave, 30kts wind**

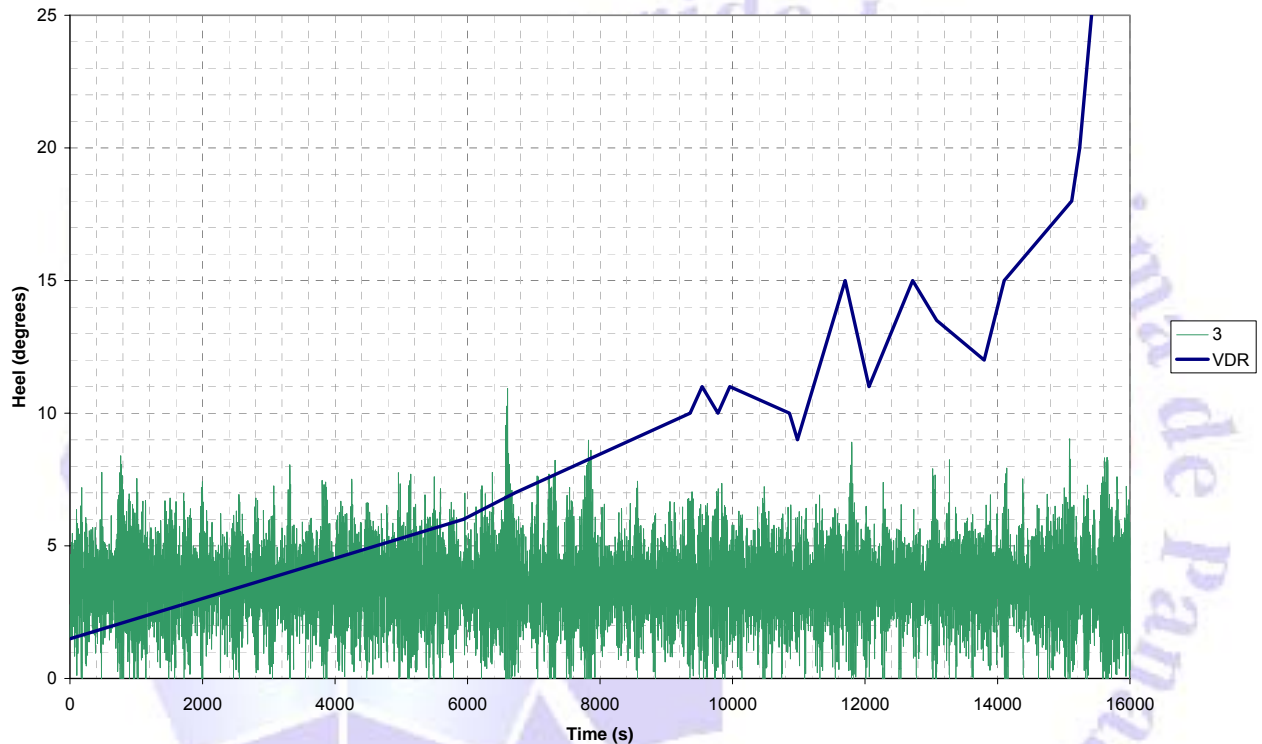
**Figure 11**

**Heel over time for Run 3. Scuppers fully operational, 3m/5.5sec zero crossing period wave, 30kts wind**

These results show that with the water flowing through the scuppers in the way they were designed, the vessel would, then the ship would capsize in less than half the time it actually took for the ship to capsize. This suggests that the scuppers may only be partially blocked.

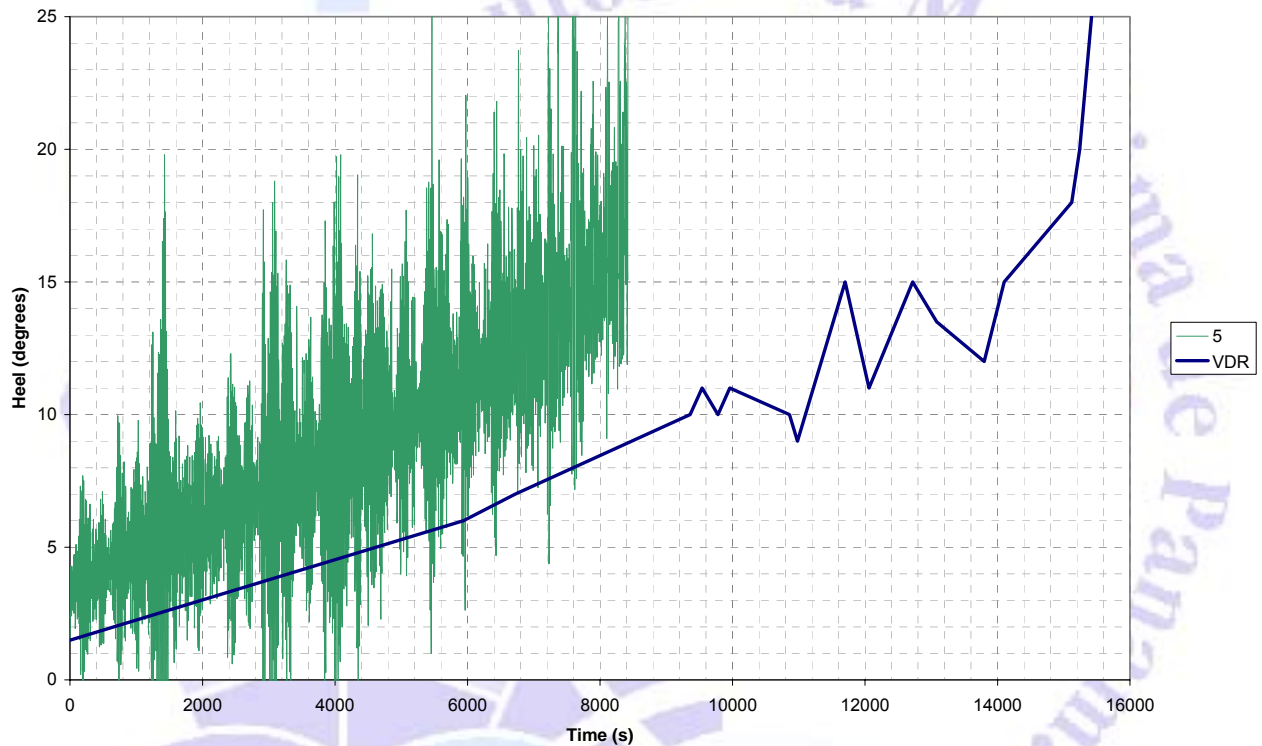
**Graph of heel over time for Run 5. Scupper flow equivalent to 4, 3m/5.5sec zero crossing period wave, 30kts wind.**

**Figure 12** shows that by restricting the flow through the scuppers to the equivalent of 4 scuppers did increase the time taken to capsize. However the time for the ship to capsize is now just over 50% of the actual capsize time. Runs 7-14 were carried out to investigate the different crew accommodation flooding scenarios. Flooding to the aft accommodation (runs 9 & 10) was discounted as this did not agree with enough of the VDR data. Additionally too much water accumulated in the aft accommodation. The witness statement said that the

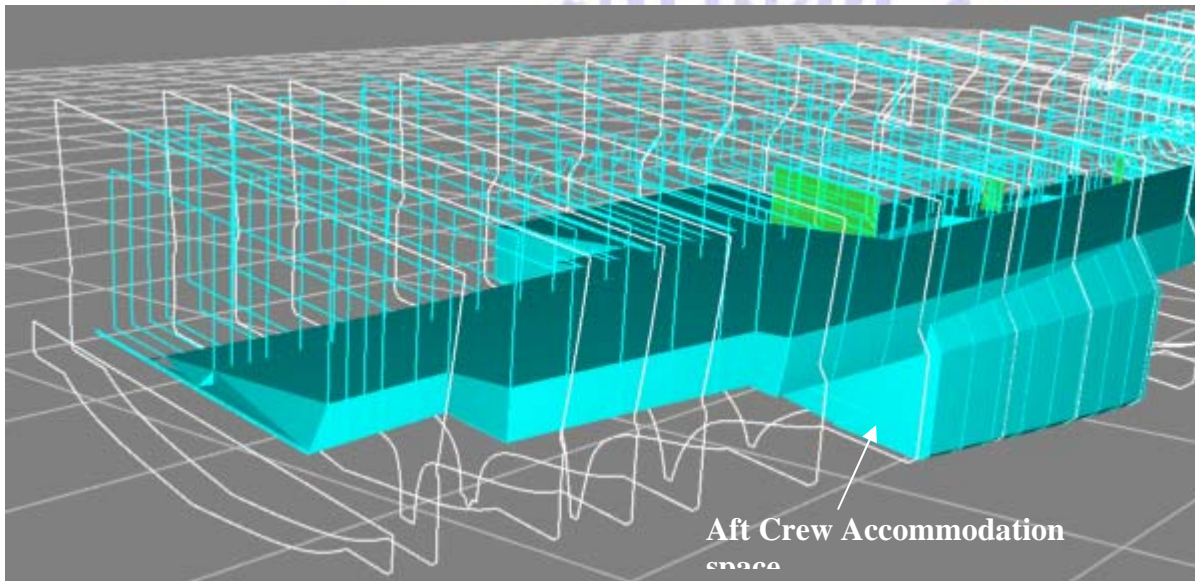
**Figure 13**

water level was 'knee high'. In scenarios where the aft accommodation was *allowed to flood, the entire space* filled. This is shown graphically in **Figure 13**.

**Image showing the flood water accumulation in the aft crew accommodation space**

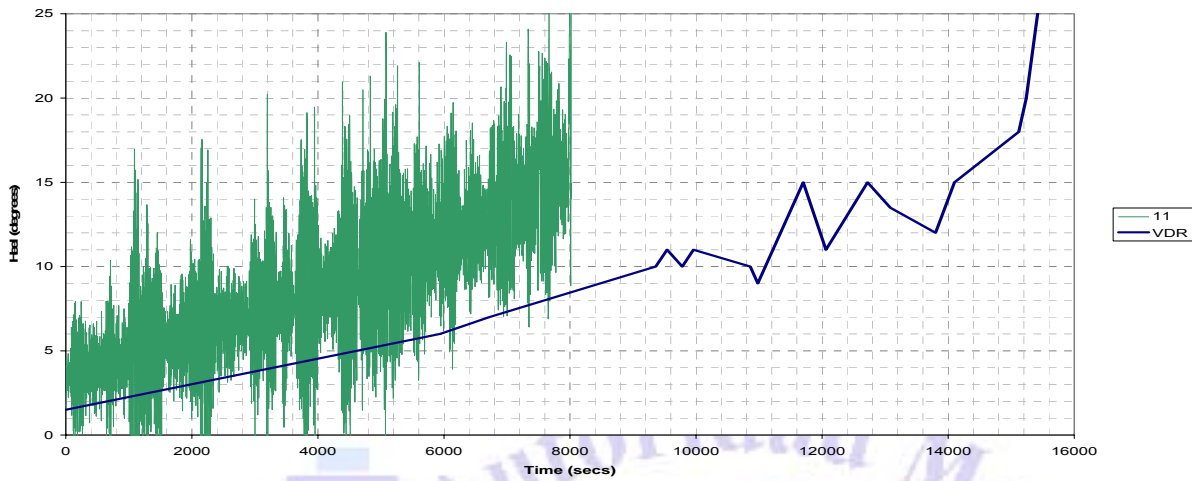
**Figure 15**

**Graph of heel over time for run 11. Scupper flow equivalent to 4, 3m/5.5sec wave, 30kts wind, down flooding to forward crew accommodation.**

Runs 11 to 14 were chosen as the most likely scenarios. In these runs 11 and 13 are in D1 loading condition and 12 and 14 in D2 loading condition. Runs 11 and 12 had the watertight door between the two forward accommodation spaces closed and in Runs 13 and 14 the

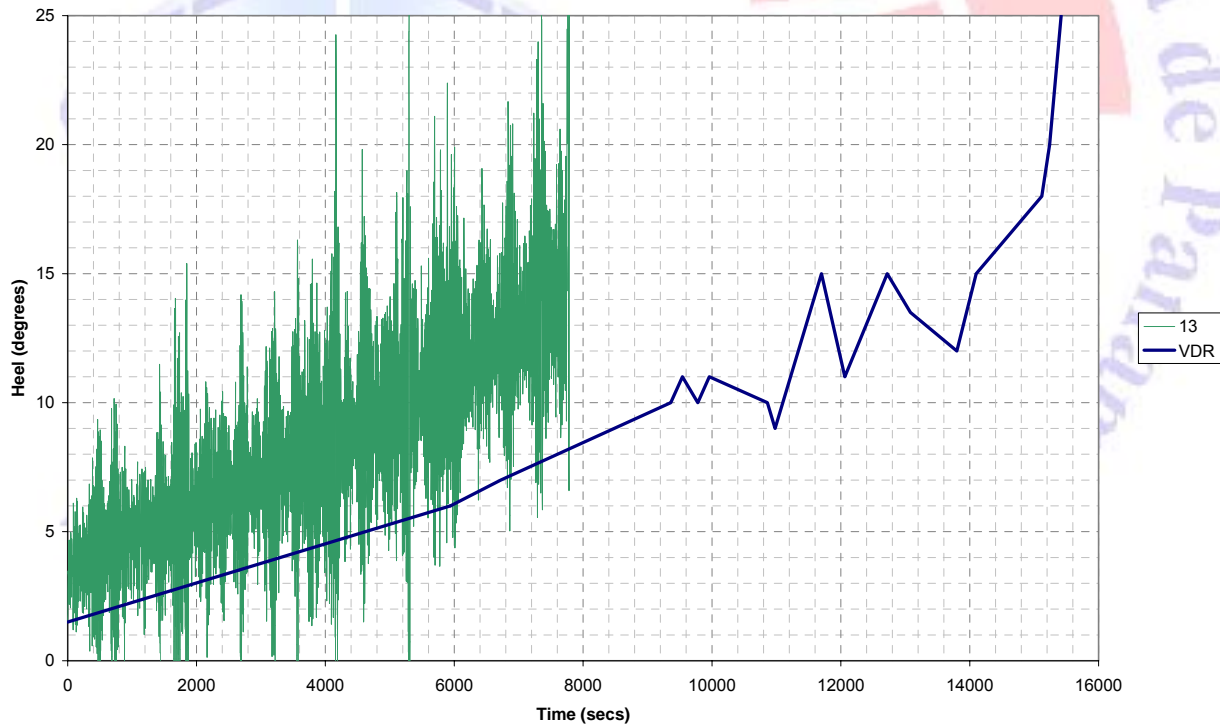
**Figure 16**

**Graph of heel over time for run 13. Scupper flow equivalent to 4, 3m/5.5sec waves, 30ktst wind, down flooding to forward crew accommodation. WT door open.**

watertight door is open. Analyzing the above results, it appears that the watertight door between the compartments has very little effect on the outcome. Due to the location of the door very little water if any, would have been able to flow through it. As the door could have been open, this scenario was still considered in further analysis. This scenario matches a lot of the VDR data. The water was flooding through a door we strongly suspect was open. The water accumulated in the accommodation space would seem to be consistent with the witness statements. Further runs were carried out on scenarios 11 – 14 with varying flow rates through the scuppers. The flow rate was increased by the equivalent of 1 scupper for each run. A result was achieved for both loading conditions which had a capsize time close to the actual time it took for Al Salam Boccaccio 98 to capsize. The final runs are summarized in Table 7 below. These runs show that between 6 and 7 scuppers must have been flowing in order for the Al Salam Boccaccio 98 to capsize in the timescale reported in the VDR data

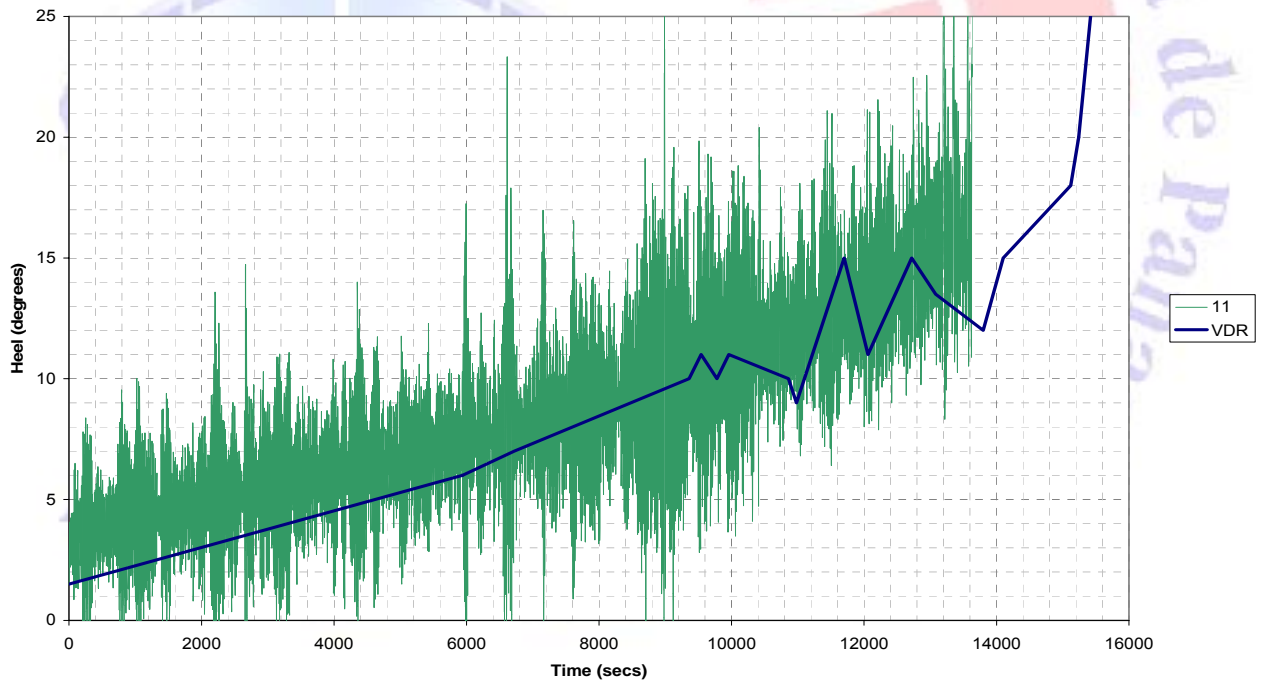
**Figure 17**  
**Heel over time for Run 11. Scupper flow equivalent to 6, 3m/5.5sec wave, 30kts wind, down flooding to forward crew accommodation.**

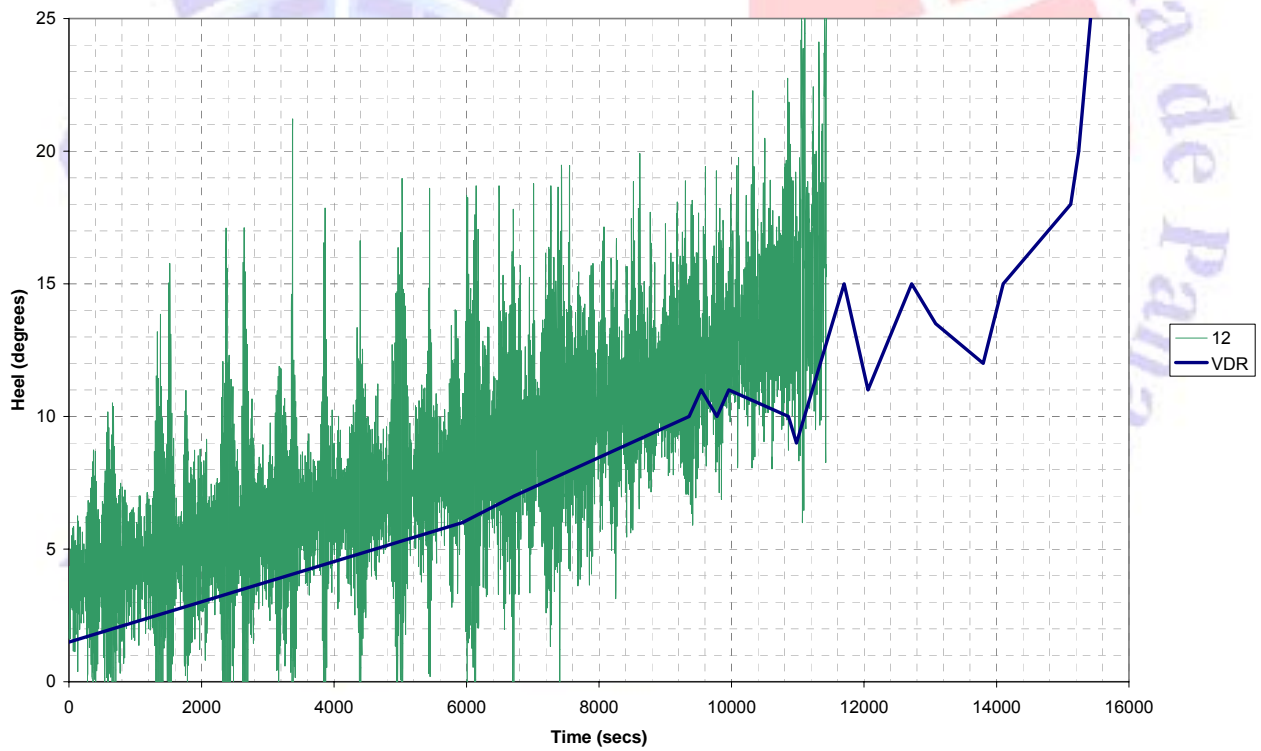
**Figure 18**

**Heel over time for Run 12. Scupper flow equivalent to 6, 3m/5.5sec wave, 30kts wind, down flooding to forward crew accommodation.**

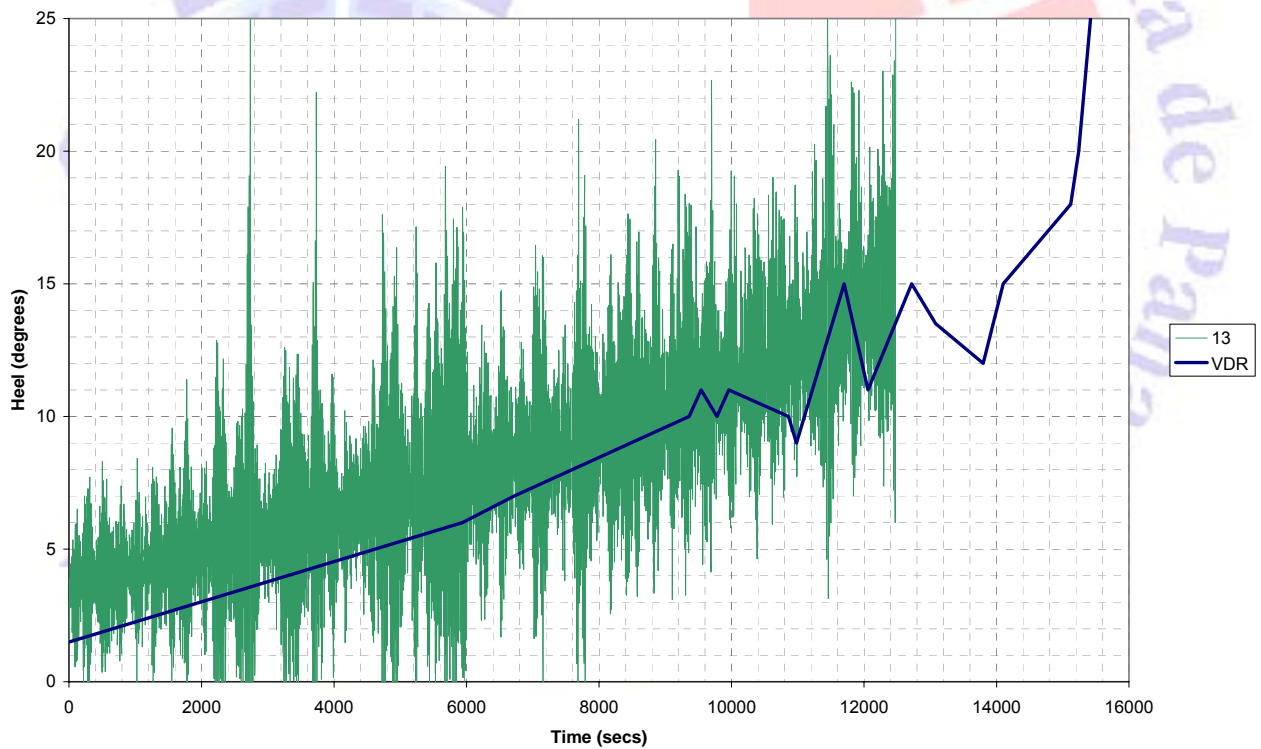
**Figure 19**

**Heel over time for Run 13. Scupper flow equivalent to 6, 3m/5.5sec waves, 30kts wind, down flooding to forward crew accommodation. WT door open.**

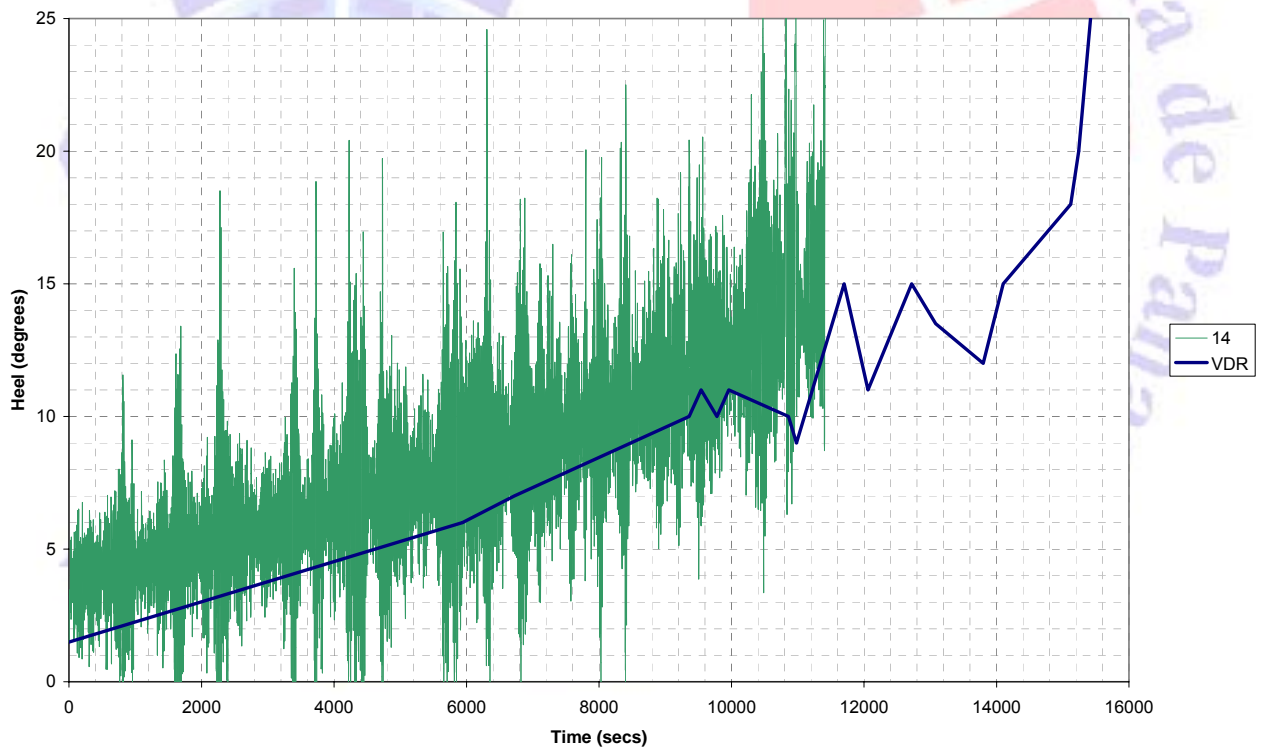
**Figure 20**

**Heel over time for Run 14. Scupper flow equivalent to 6, 3m/5.5sec waves, 30kts wind, down flooding to forward crew accommodation. WT door open.**

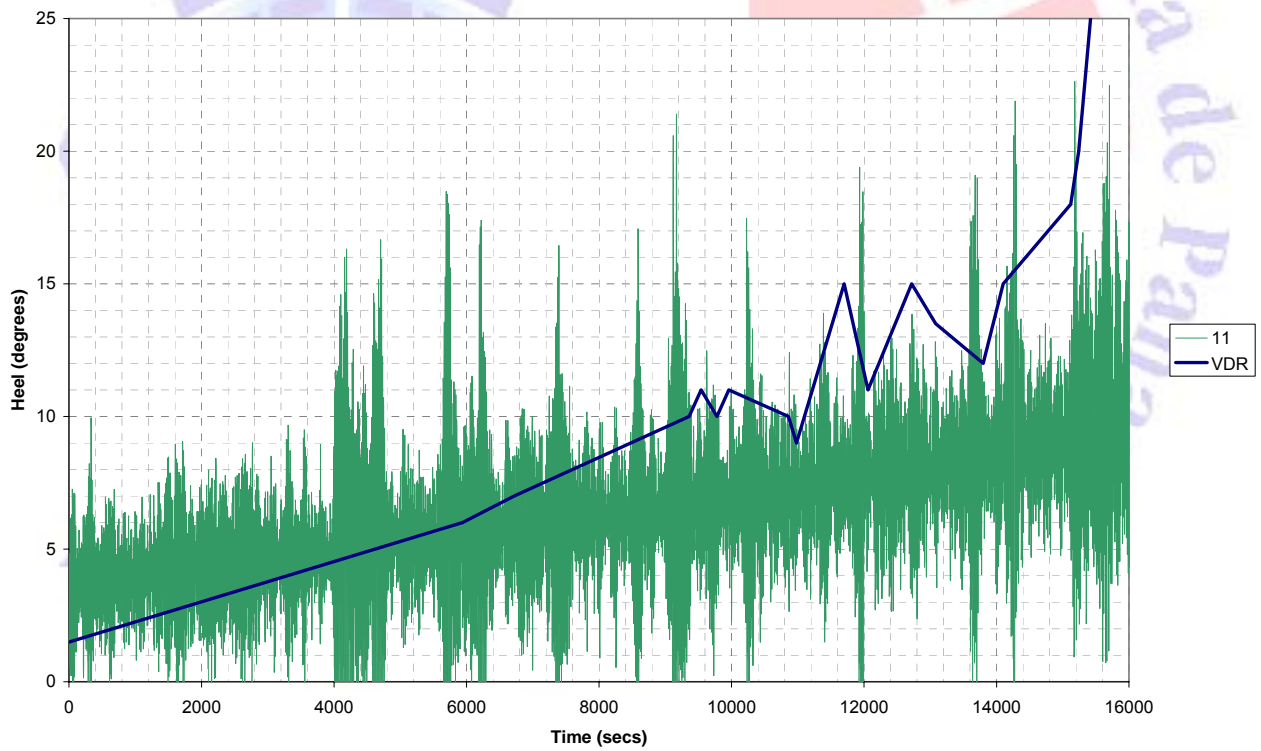
**Figure 21**

**Heel over time for Run 11. Scupper flow equivalent to 7, 3m/5.5sec wave, 30kts wind, down flooding to forward crew accommodation.**

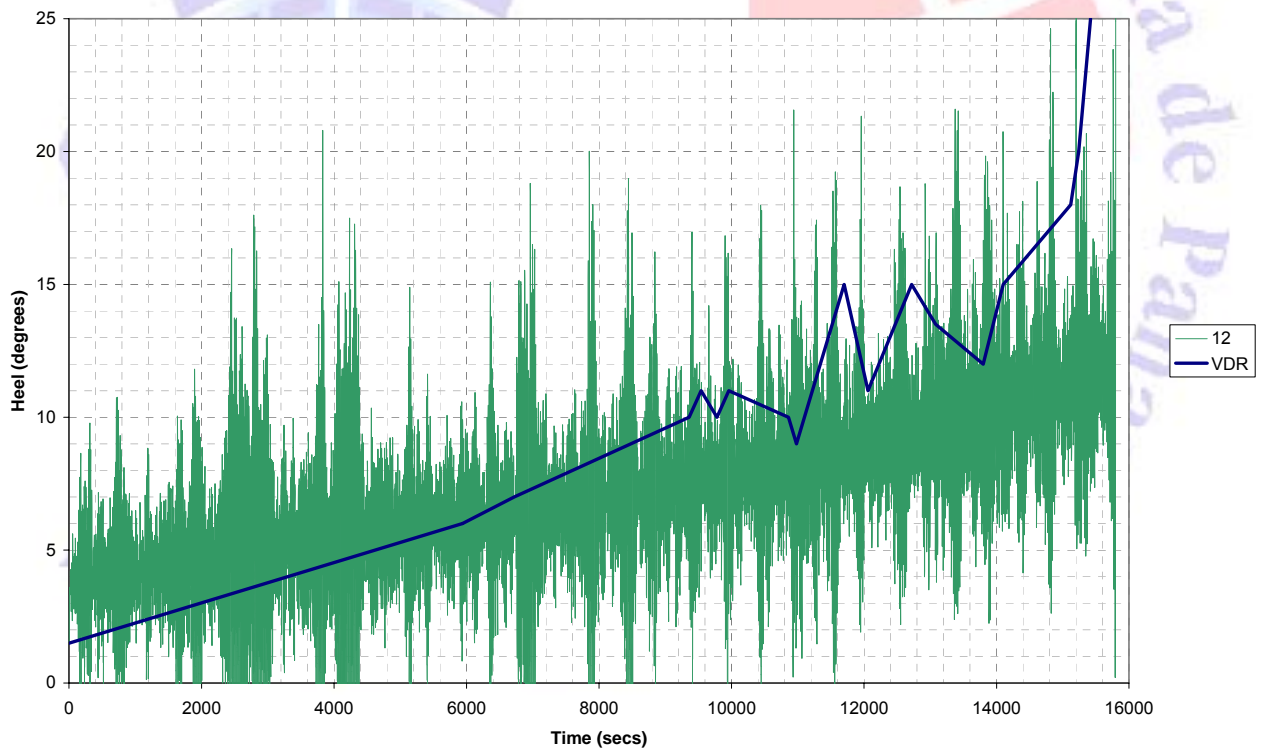
**Figure 22**

**Heel over time for Run 12. Scupper flow equivalent to 7, 3m/5.5sec wave, 30kts wind, down flooding to forward crew accommodation.**

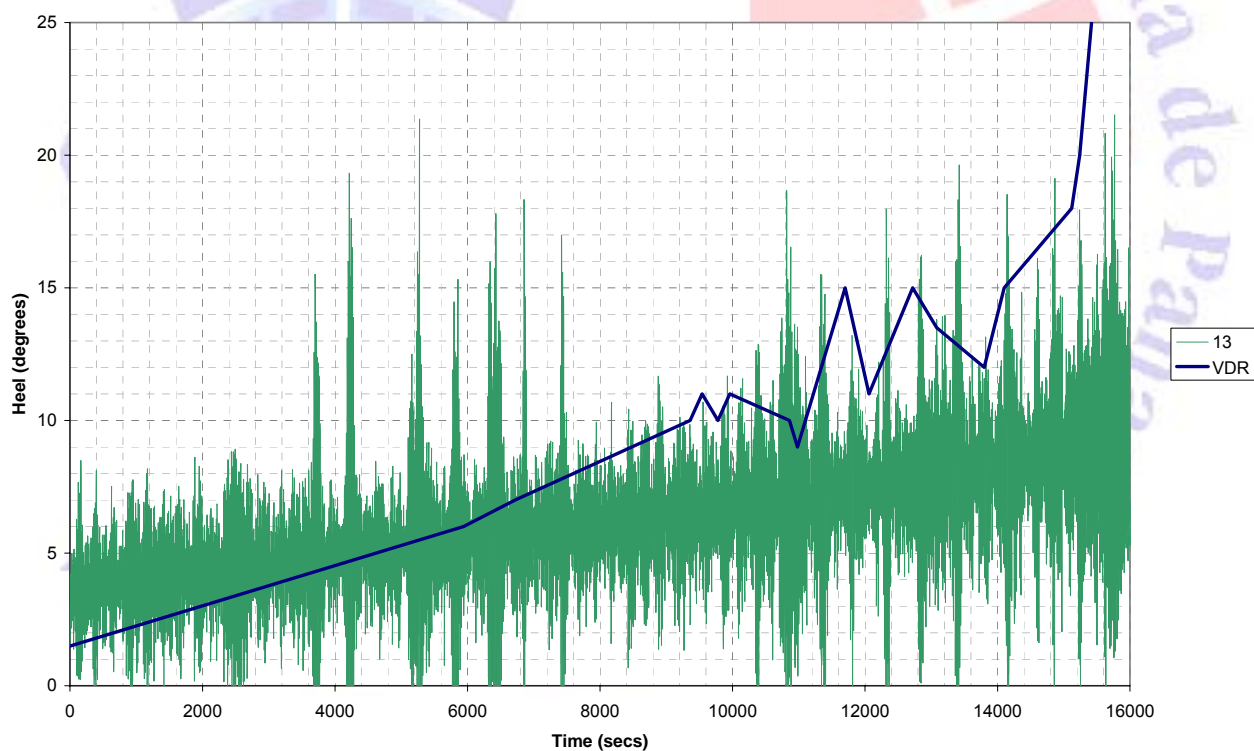
**Figure 23**

**Heel over time for Run 13. Scupper flow equivalent to 7, 3m/5.5sec waves, 30kts wind, down flooding to forward crew accommodation. WT door open.**

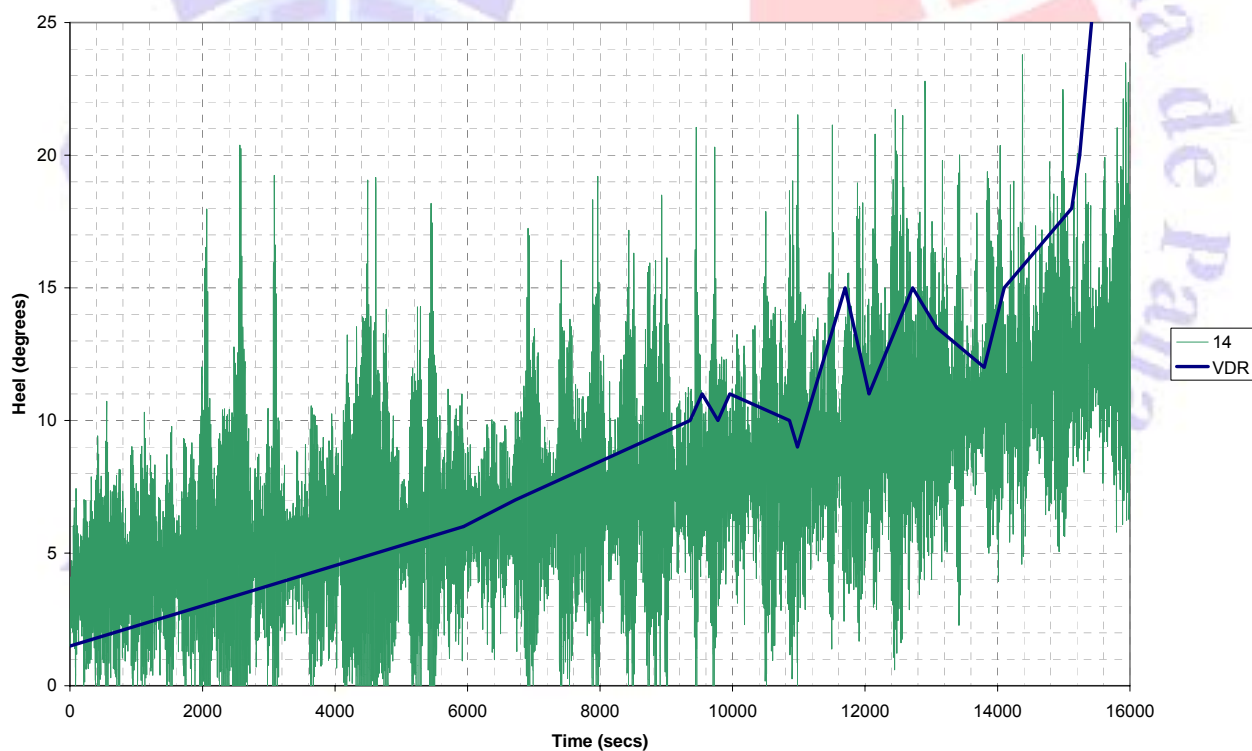
**Figure 24**

**Heel over time for Run 14. Scupper flow equivalent to 7, 3m/5.5sec waves, 30kts wind, down flooding to forward crew accommodation. WT door open.**

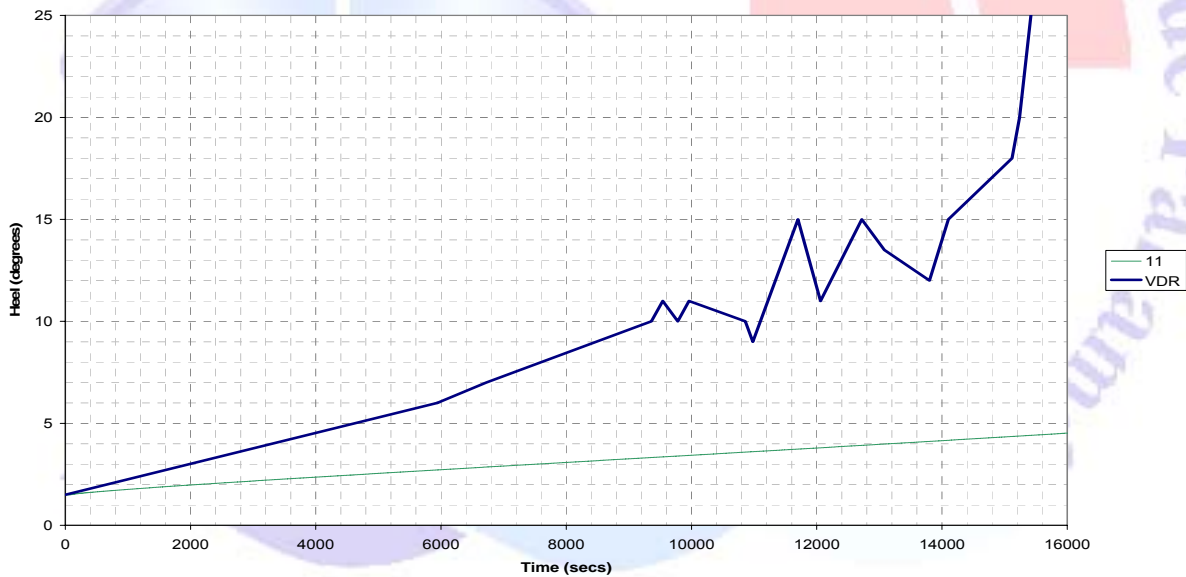
**Figure 25**

**Run 11 without wind or waves. Scupper flow equivalent to 6, down flooding to forward crew accommodation.**

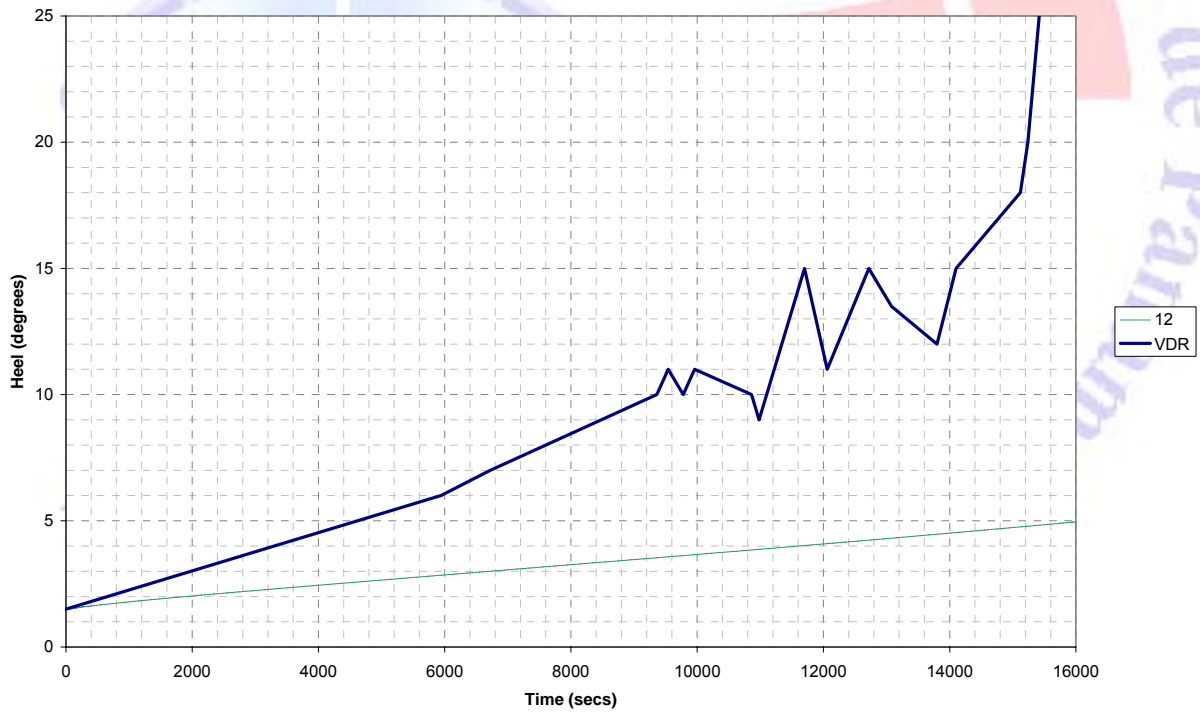
**Figure 26**

**Run 12 without wind or waves. Scupper flow equivalent to 6, down flooding to forward crew accommodation.**

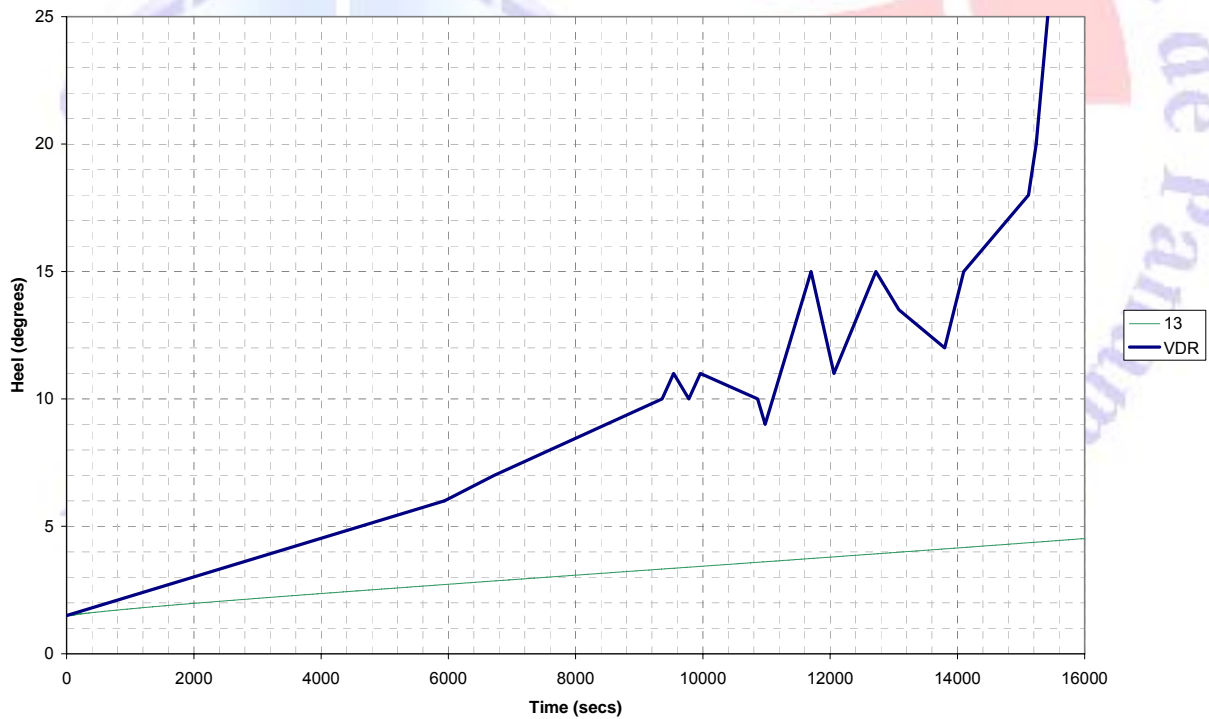
**Figure 27**

**Run 13 without wind or waves. Scupper flow equivalent to 6, down flooding to forward crew accommodation. WT door open.**

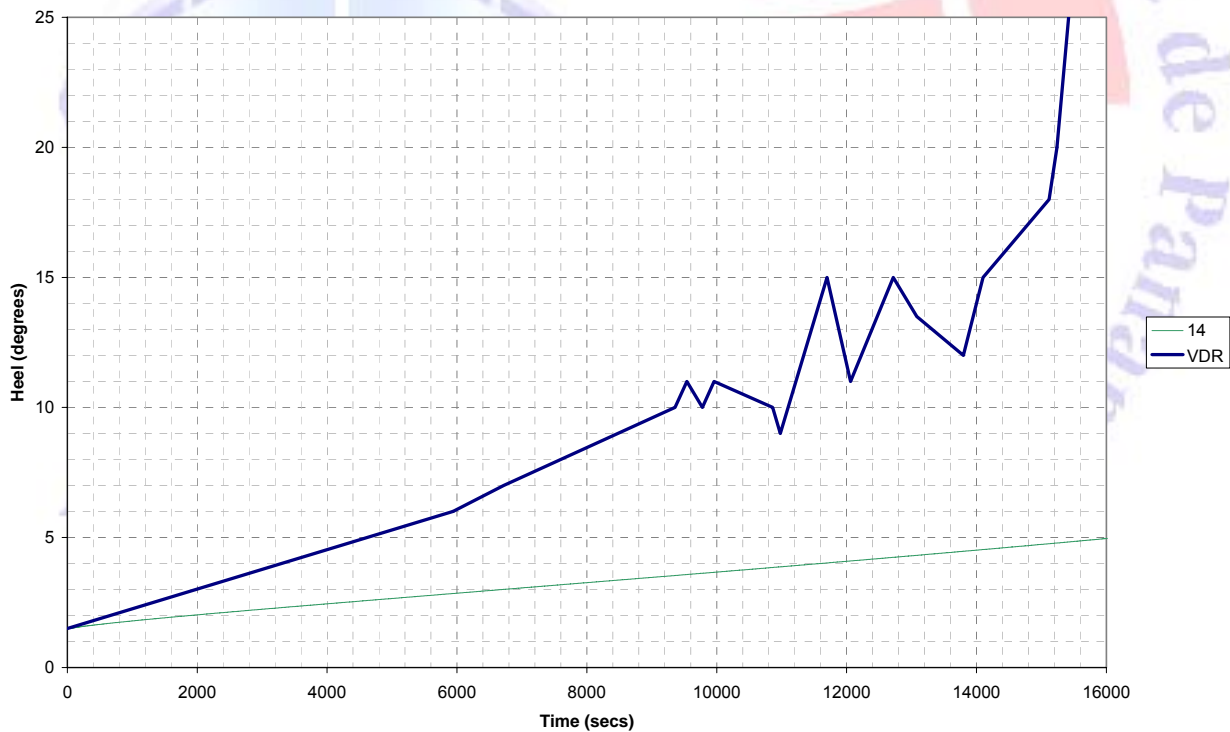
**Figure 28**

**Run 14 without wind or waves. Scupper flow equivalent to 6, down flooding to forward crew accommodation. WT door open.**

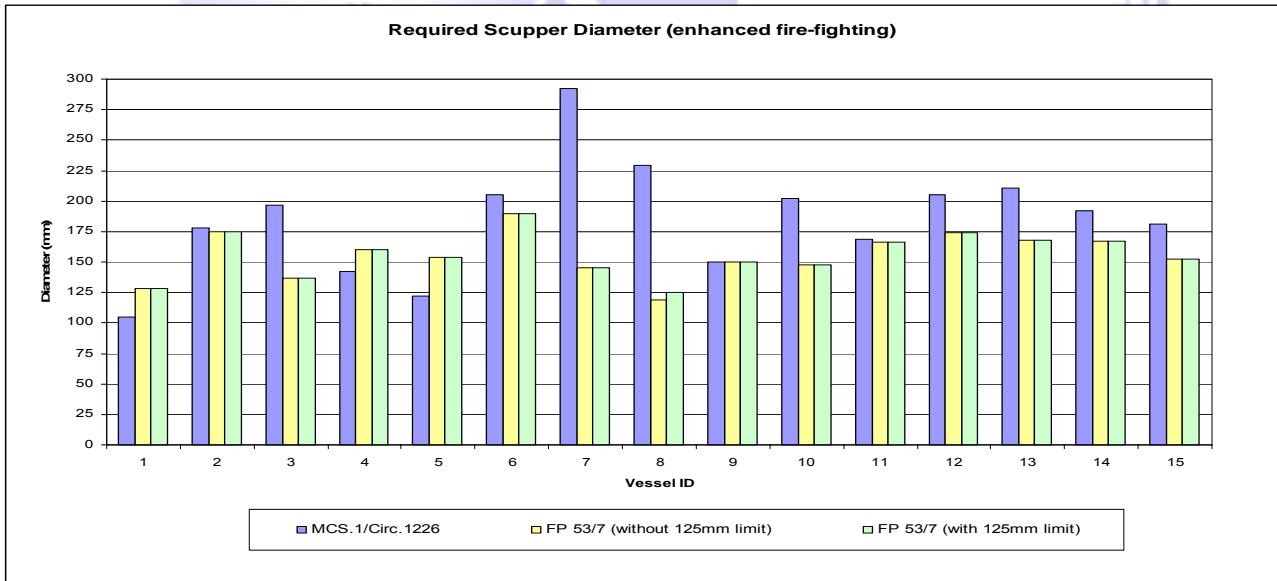
**Figure 39**  
**Required scupper diameter for MSC.1/Circ. 1226 and FP53/7 with 125 mm minimum diameter requirement and without.**

Calculations carried out on the basis of equilibrium of flow (with additional margins as specified in MSC.1/Circ.1226 and FP 53/7 ) for the minimum required fire fighting capacity will produce scupper diameters between 50 -100 mm. This is considerably smaller than today's standard practice and the requirements given by some class societies and flag administrations.

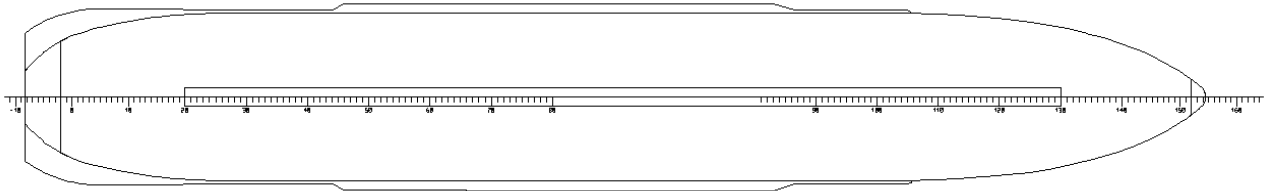
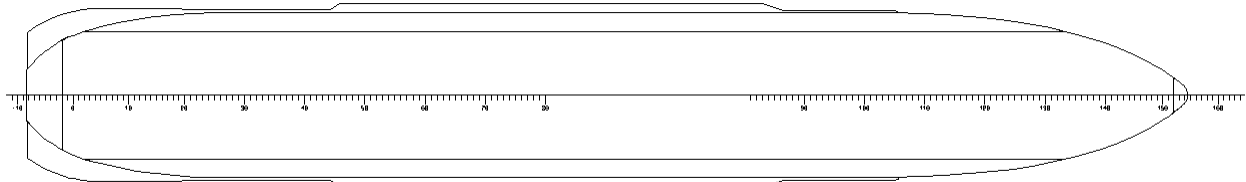
**Figure 40**

Diagram of the deck layout used for the centre casing condition for Ship 1

Diagram of the deck layout used for the side casings condition for Ship 1
