# FINAL INVESTIGATION REPORT

**M/V “AL SALAM BOCCACCIO 98”**

**February 03<sup>th</sup>, 2006**

***R-054-09/DIAM***

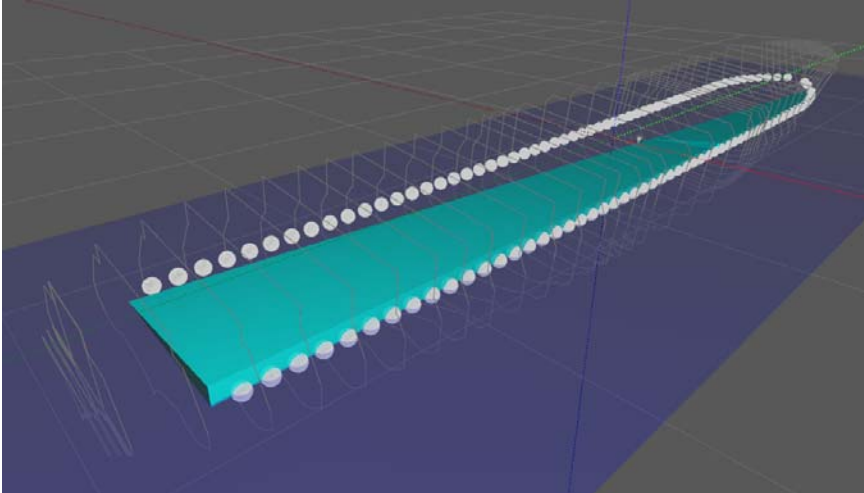
A series of scuppers (at 2.0 m intervals) were modeled on both sides of the deck. Their functionality is similar to the real scupper arrangements, i.e. they register flow every time water is occupying the space directly above them. The intention of high density of the artificial scuppers on the deck is to provide with detailed view of the movement of water due to ship motions.

**Figure 41**  
**Proteus model showing the position of the openings**

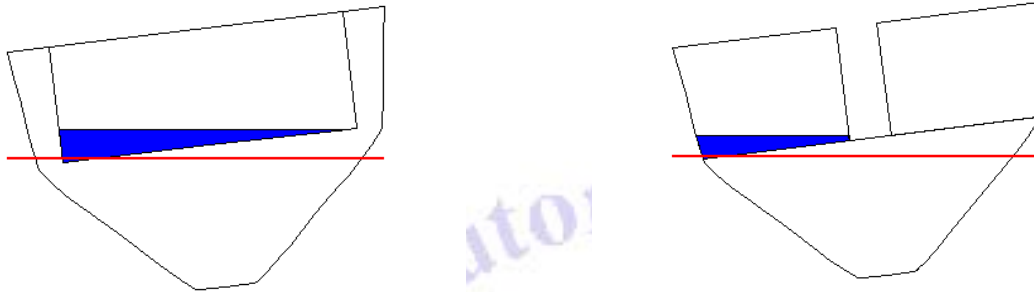
**Figure 42**

**Section through the hull showing the (i) side casing and (ii) the central casing and the water on deck**

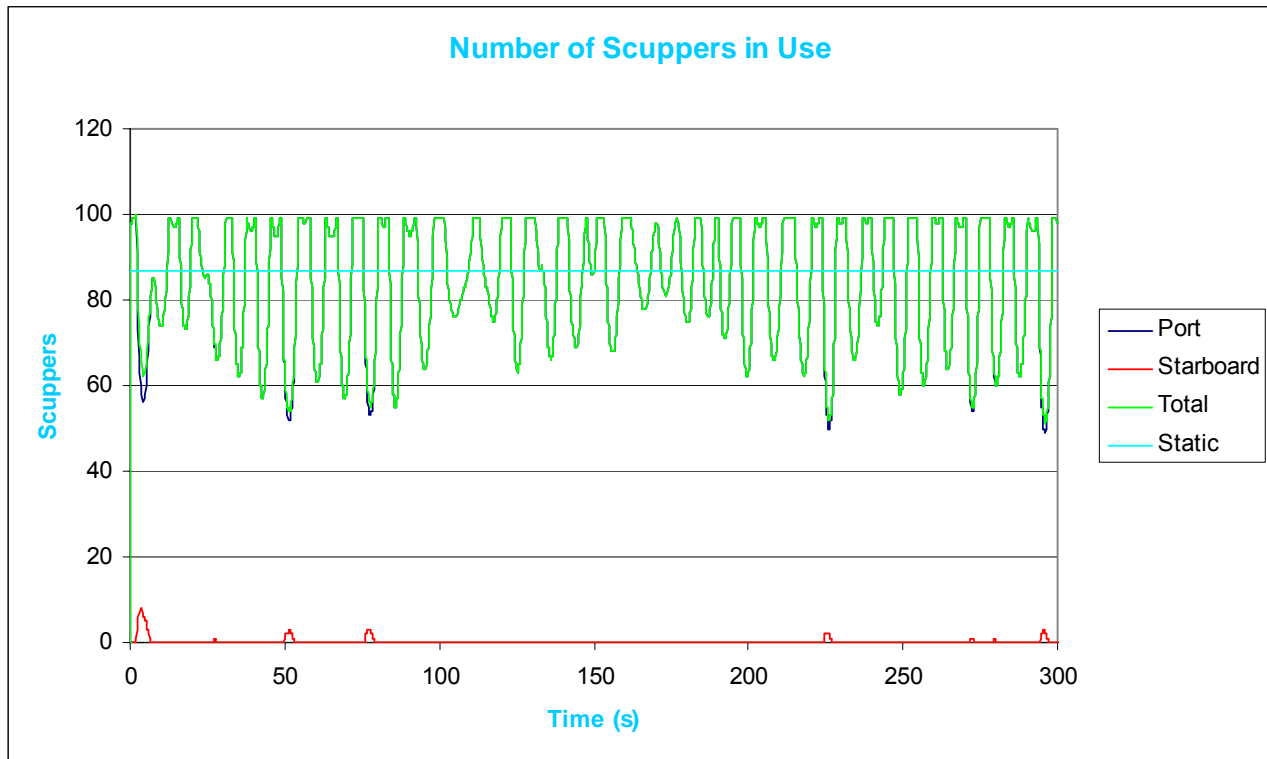
**FIGURE 43**

The results show that the movement of water on the deck will reduce the effectiveness of the scuppers and the total outflow (Figure 43) and partially show the range of movement of water on deck. **Figure 43** shows the number of scuppers draining on each side of the vessel plus the total compared to the static. Table 22 shows the percentage of time each scupper was draining water from the deck.

The number of active scuppers during the simulation for Ship 2 in bow trim to wave action at any given moment. **Table 21** and **Table 22** give the number of scuppers draining on average for the 300s simulation for the Port and Starboard sides and the Total average. These are compared to the number of scuppers which were draining during static calculations to give a reduction or increase in the number of scuppers draining on average.

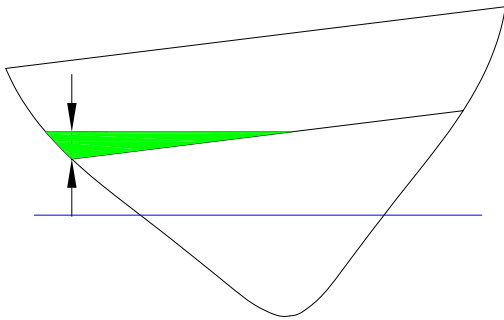
**Figure 43**

**Example of water height**

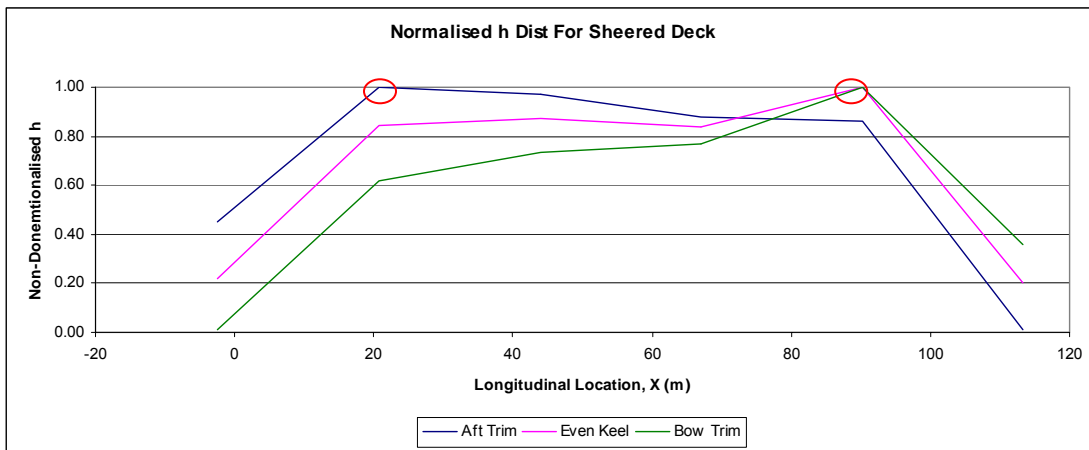
The graphs below clearly show that, for the chosen hull form and vehicle deck geometries, bow trim dominates for both sheered and flat deck configurations. The maximum water height for each curve is circled to highlight this point.

**Figure 44**  
**Normalized water height for a sheered deck**

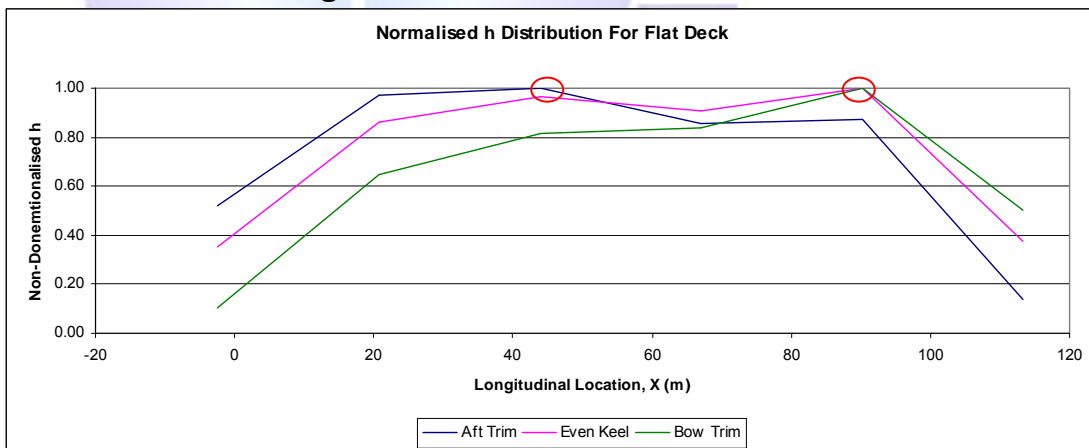
**Figure 45**  
**Normalized water height distribution for a flat deck**

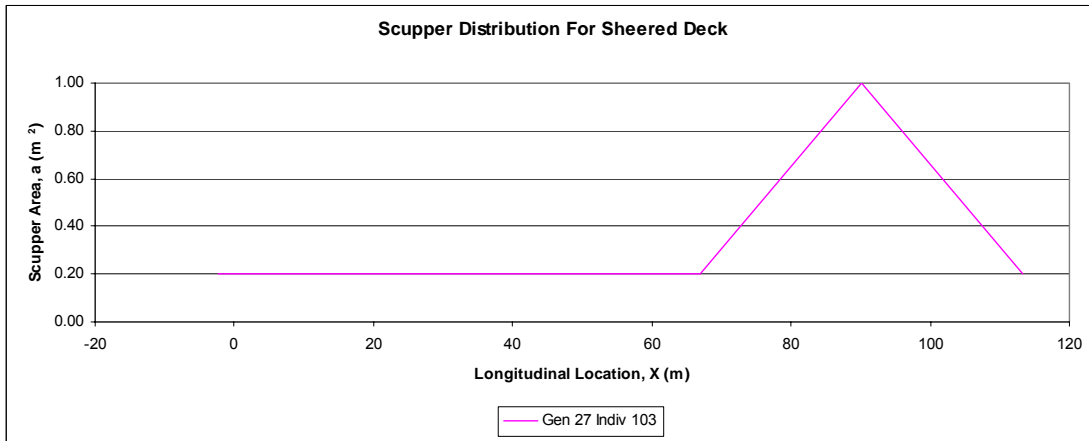
**Figure 46**  
**Optimized solution for scupper distribution on a sheered deck**

The optimization study tends to produce scupper area distributions that maximize the area positioned in the bow of the vessel due to the large build up of water within this region in bow and even keel cases.

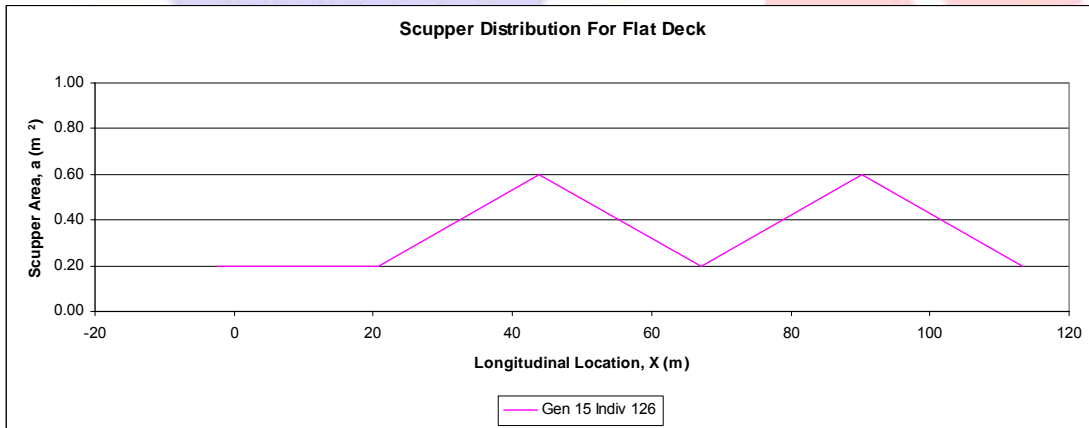
**Figure 47**  
**Optimized solution for scupper distribution on a flat deck**

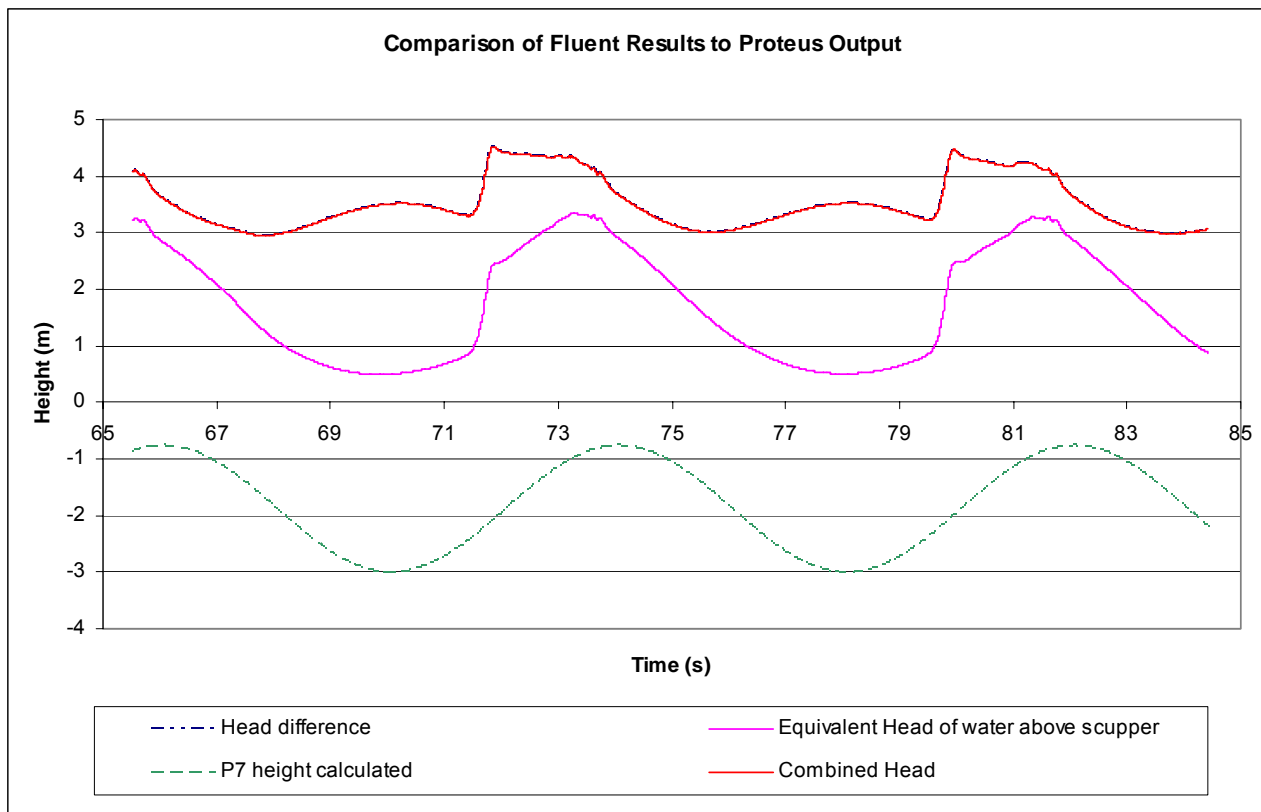
All the combined head values for Point 7 are large and positive (Figure 57, which signifies that the non-return valves of the scupper system are not taken into consideration. For a situation where the combined head in way of a scupper is zero or negative (i.e. the water level outside the car deck is above the water level inside the car deck at that scupper inlet, or there is no water above that scupper) the equivalent head value is taken as zero, and no outflow occurs through that scupper for the particular time step.

**Figure 57**  
**Time history of pressure head and roll for Point 7 in the Side Casing case**

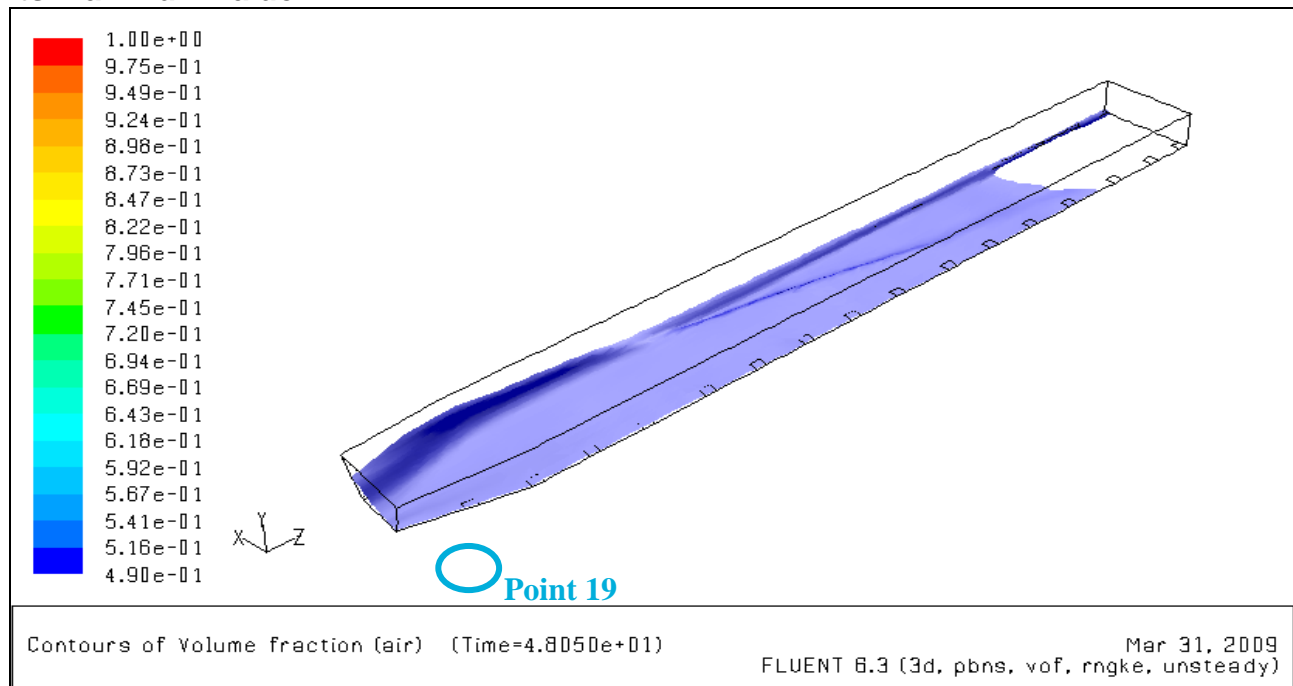
**Figure 59**

**Free surface of water in the vehicle deck when flow at point 19 is predicted to be near its maximum value**

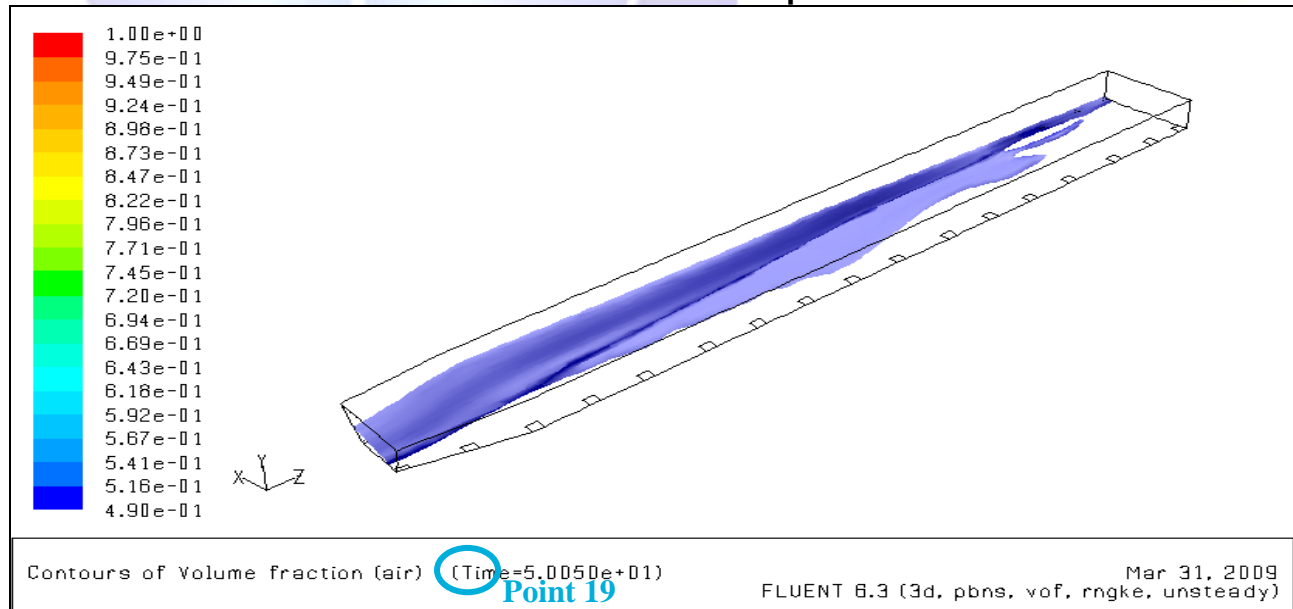
**Figure 60**

**Free surface in the vehicle deck when water above point 19 is at 0.0 m**

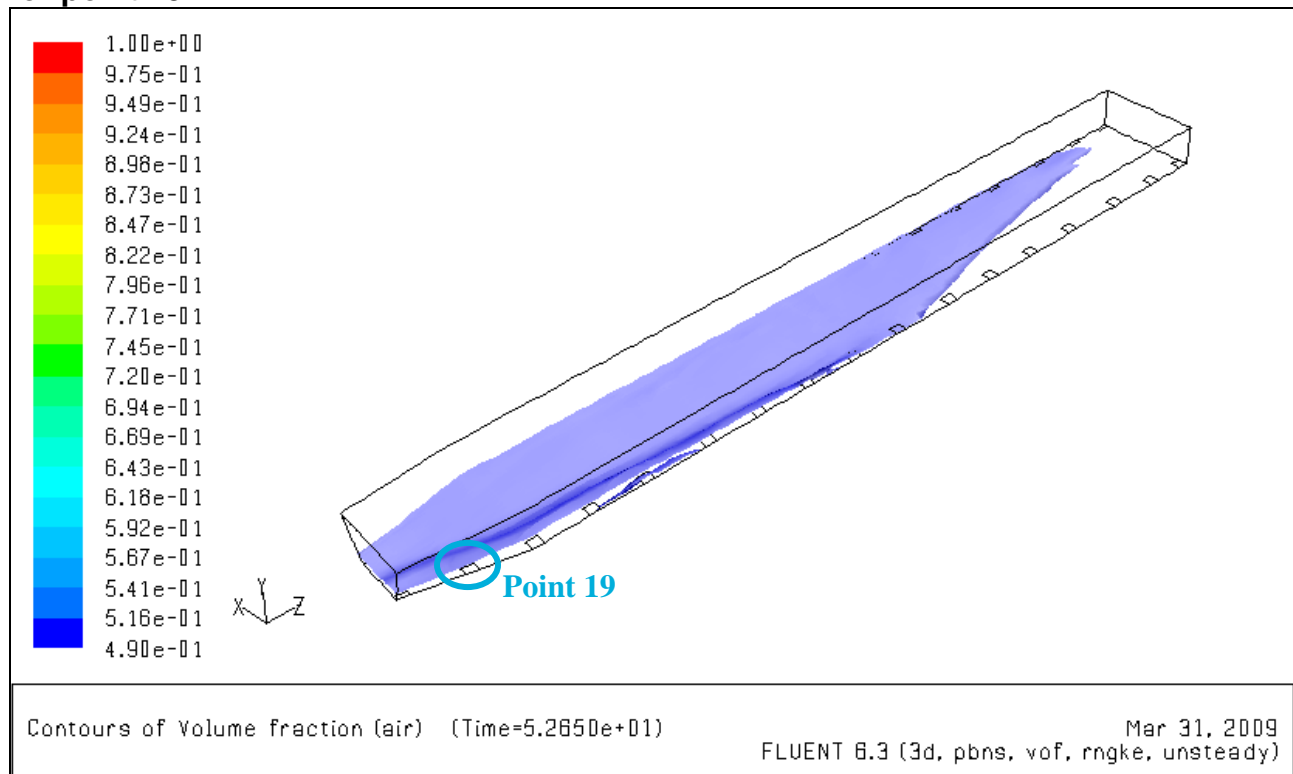
**Figure 61**

**Free surface in the vehicle deck when equivalent water head is near maximum value for point 19**

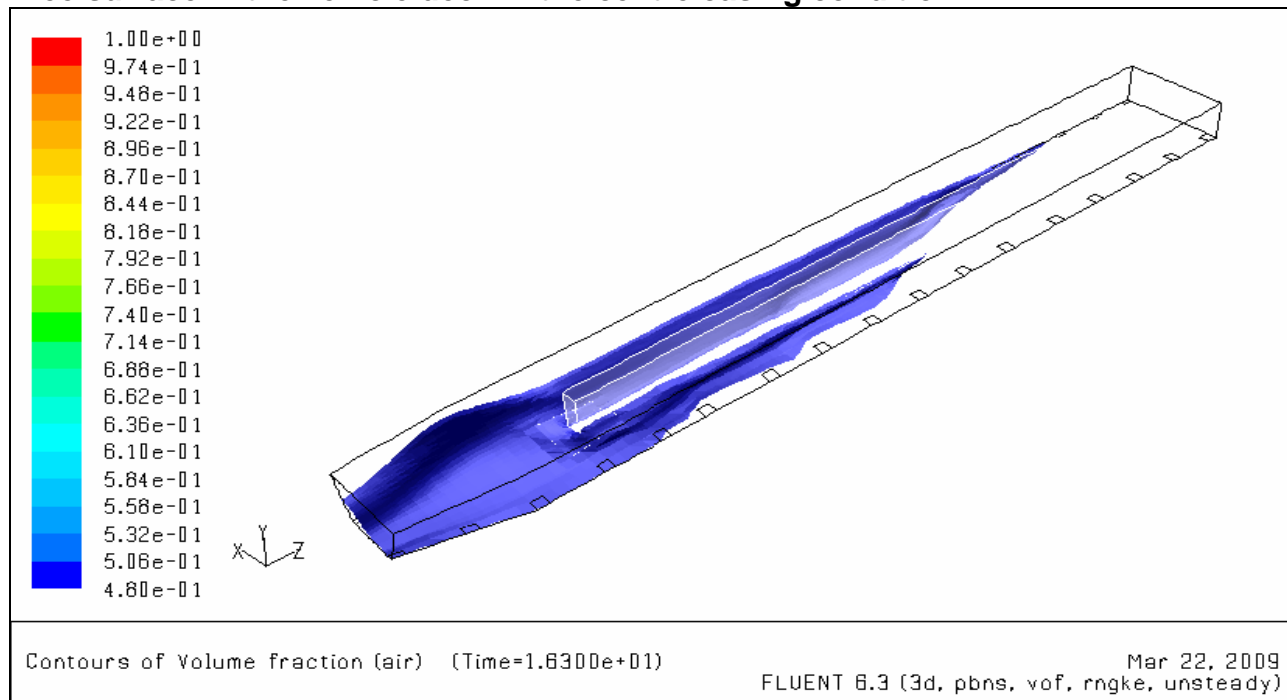
**Figure 62**

**Figure 62 to Figure 64** show the water surface on the deck for the centre casing condition. It can be seen on these figures that areas of the deck once more do no flow continuously.

**Free surface in the vehicle deck in the centre casing condition**

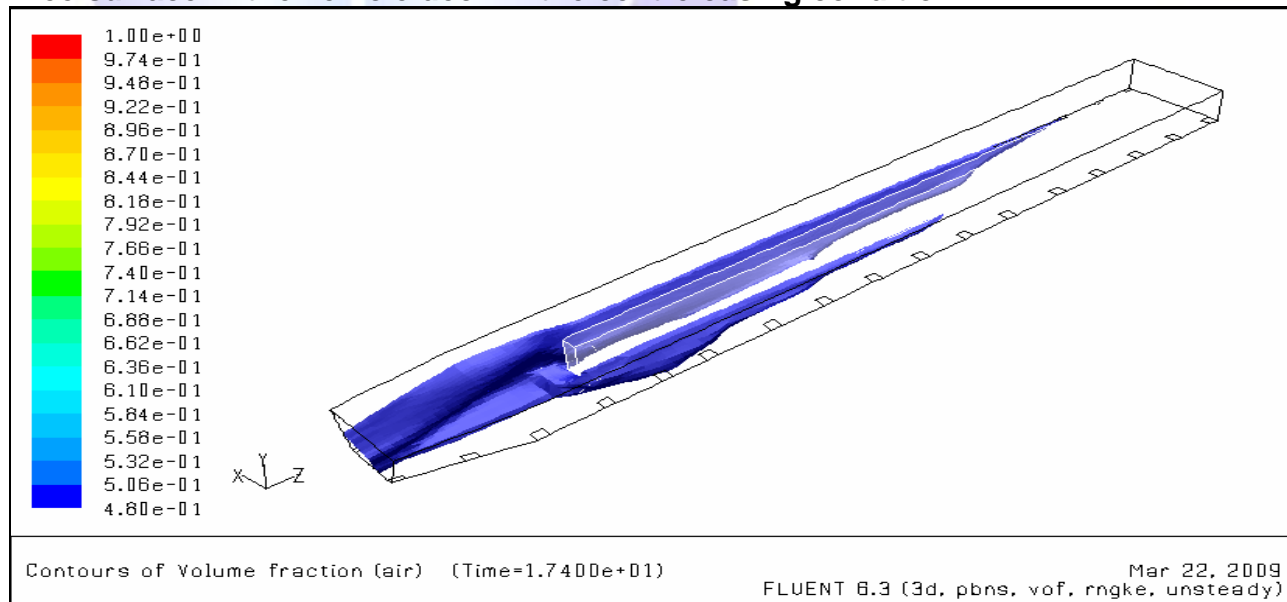
**Figure 63**

**Free surface in the vehicle deck in the centre casing condition**

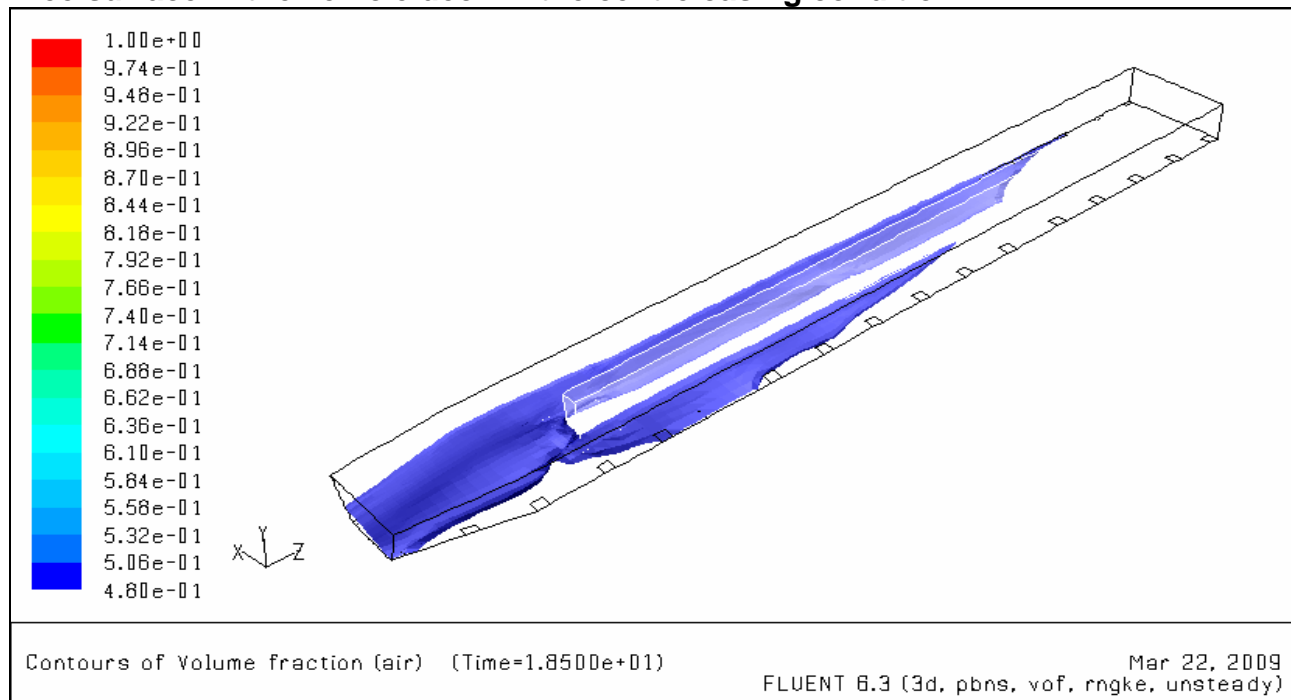
**Figure 64**

**Free surface in the vehicle deck in the centre casing condition**

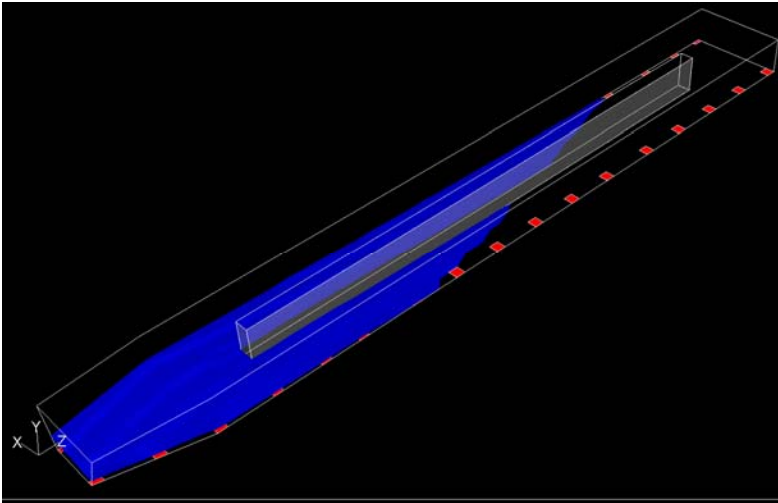
**Figure 65**  
**Water position in the static case**

In order to compare the time averaged to the total static outflow velocity, a calculation with zero ship motions was performed. The method of obtaining the static water head was similar to that used to calculate the dynamic water head. The centre casing model was set up at the desired heel and trim angles by altering the gravity vectors, and the height of the water above each scupper was calculated as described for the dynamic process. The vessel was also set to the same heel and trim values in the PROTEUS 3 model in calm sea and the heights of the points above the water level were measured. The average static head of water for active scuppers was calculated to be 2.45 m. The water rests in the static condition as shown in Figure 65.

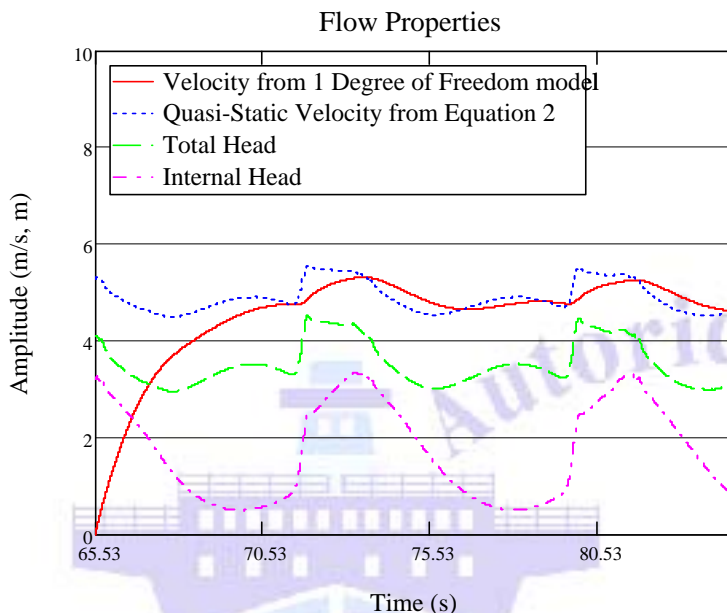
**Figure 66**  
**Flow properties for Point 7 in the 1 Degree of Freedom Side Casing model**

In order to take into account the momentum variation in the scupper piping, the 1DOF model was used to calculate the outflow velocities. The effect of the 1DOF model is to smooth abrupt velocity changes and alter the average velocity over the duration of the simulation. Two examples of this can be seen in **Figure 66** and **Figure 67** for points 7 and 19 respectively, for the deck with the side casing.
