**Technical Report**  
**Issued by the technical Committee**  
**established to Investigate and analyze the causes**  
**which led to the sinking of the Passenger Ferry**  
**Al Slam Boccaccio 98 in the Red Sea in**  
**February 2006**

Arab Republic of Egypt  
Alexandria  
June 2006

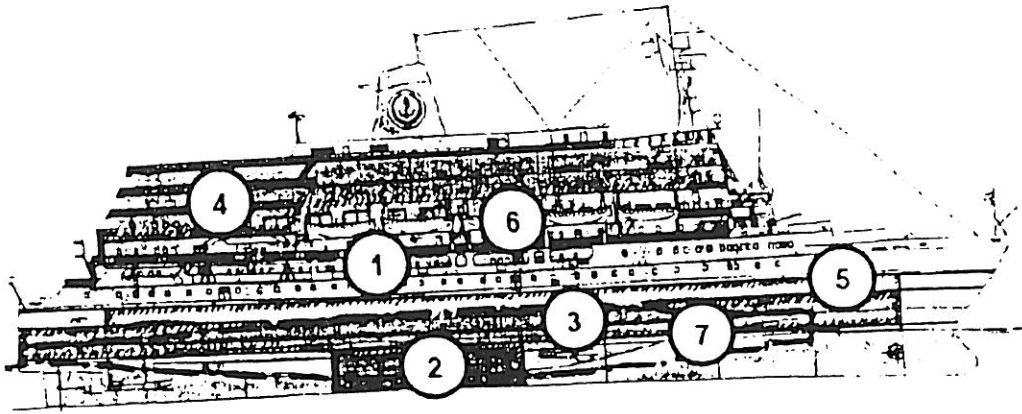
In 1990-1991 the ship has been modified by adding three superstructures decks and Sponsons.

Al Salam Boccaccio 98 illustrated by numbers in the above diagram

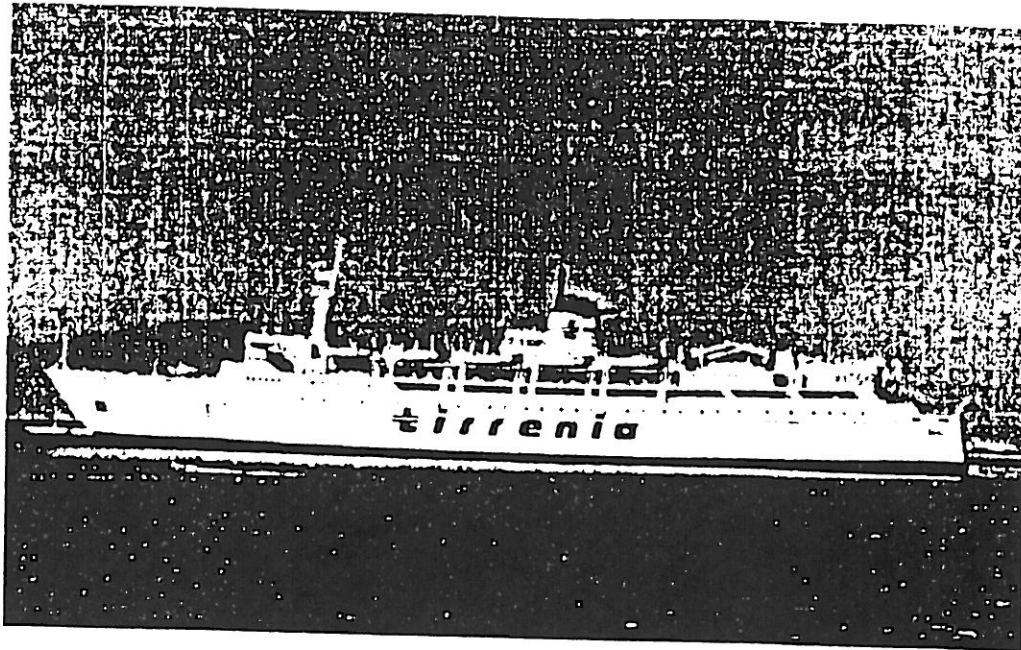
In 1990 the ferry was modified in a shipyard called SEBM in Naples (Italy) in order to fit car decks at mid height of the main car deck between frames 26 and 160. The fire extinguishing system was provided with a fixed water spray system in the garage to comply with SOLAS 74 and amendments.

The Ferry Al Salam Boccaccio 98 before modifications

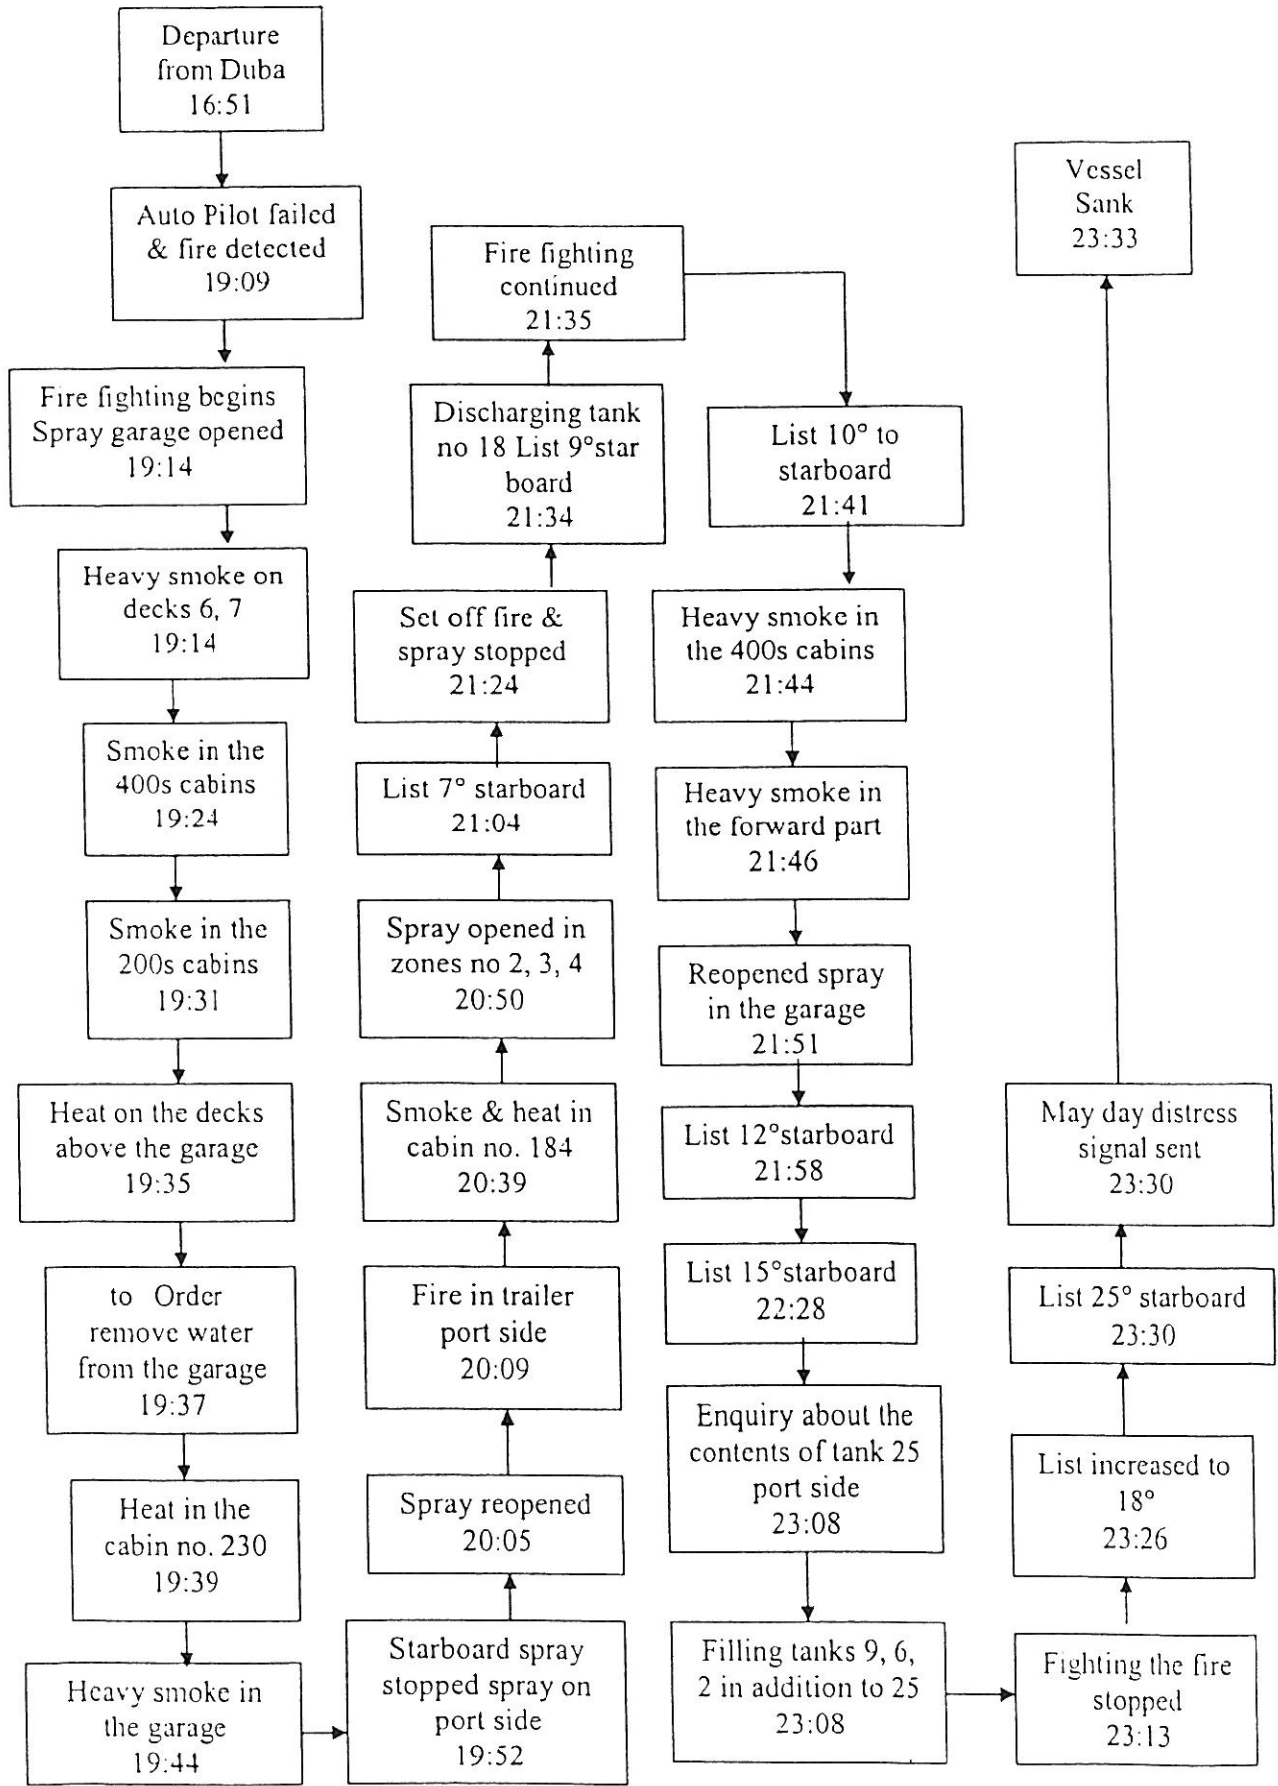
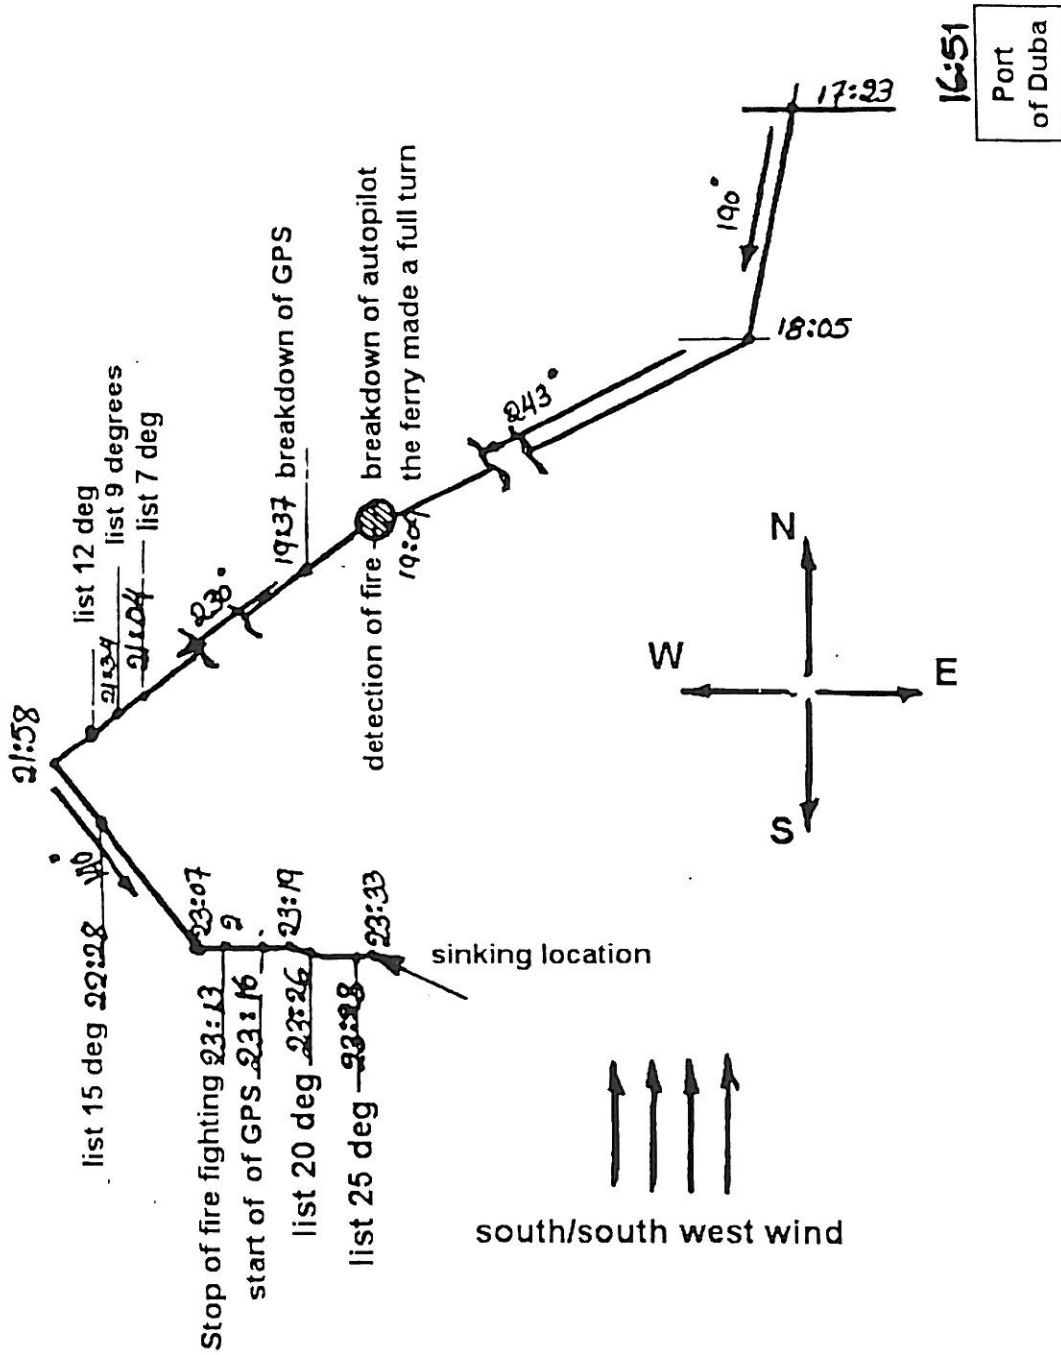
**Flowchart of sequences of  
voyage events  
According to the `VDR`  
and a map of the ferry's course  
during her last voyage**

- Autopilot failure led to loose control on the ferry's course and her turning, as appeared in the data of the VDR. Please refer to the map (Annex No. 4).

A map showing the ferry course during the voyage
